Field Measurement of Vertical Movement and Roof Moisture Performance of the Wood Innovation and Design Centre: Instrumentation and 1st Year's Performance

March 2015

301008940: Field Testing and Monitoring of WIDC Building

Confidential Contract Report

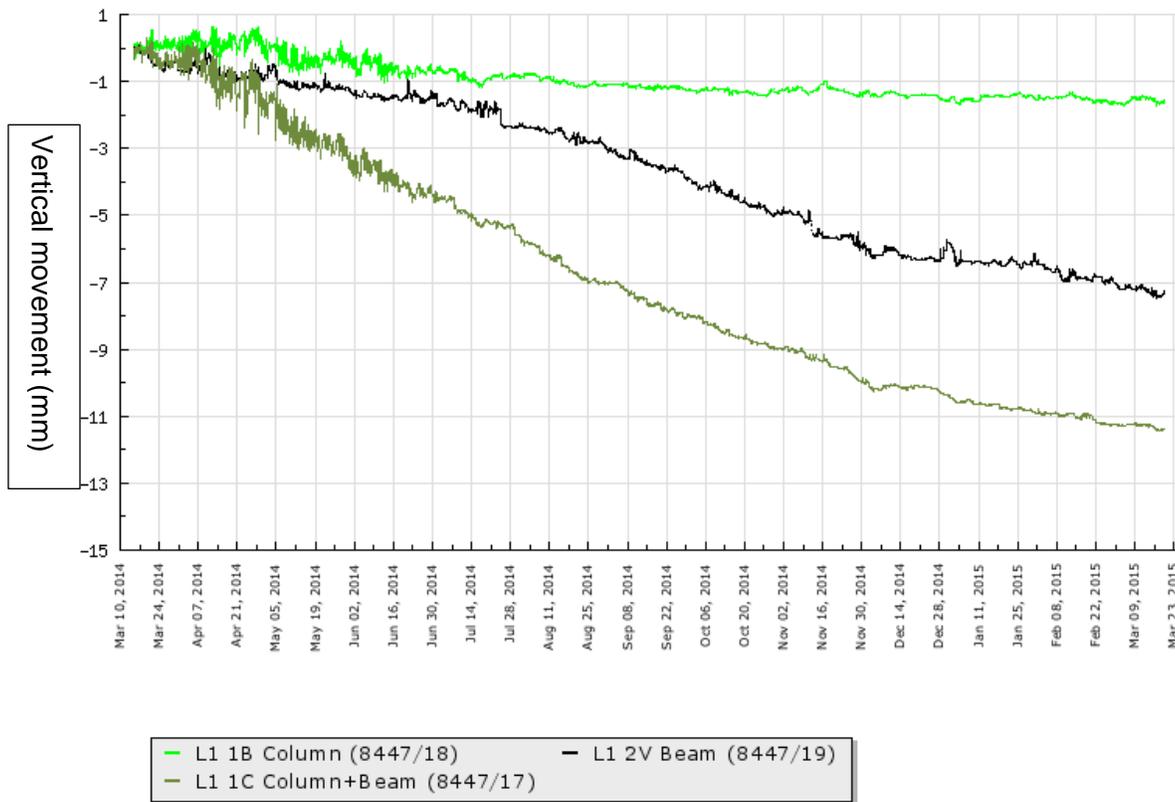
The results from the displacement sensor installed at Location 1, labelled "L1 1C Column", show that the glulam column was extremely stable under compression, with the maximum shortening amount of about 1.5 mm (Figure 9). The sensor labelled "L1 1B Column+Beam", covering the entire glulam column and the PSL beam above (with a metal connector between them), showed a shortening amount of about 11 mm. The sensor ("L1 2V Beam") measuring the PSL beam but excluding the two loading surfaces (i.e., excluding the contact areas with the CLT floor above and the glulam column below) showed a movement amount of about 7 mm. These measurements indicate that the PSL beam was a major contributor to the vertical movement at this location, with an estimated movement amount of 9 mm for this beam alone. Apparently deformation resulting from compression occurred not only at the surface loading areas, but also along the entire depth of the beam. From the two sensors installed over the PSL beam and showing the largest movement amounts observed in this study (i.e., "L1 1B Column+Beam" and "L1 2V Beam"), the movement increased over time; but it appears that the increases were faster before December 2014; both slowed down after that. Such changes should be attributable to changes in the indoor environment and consequently the wood MC. While the temperature inside the building was controlled around 20°C after the building was occupied, the RH change is mostly seasonal depending on the exterior conditions as well as the amount of heating and ventilation (i.e. air exchanges). Indoor environment tends to be very dry under heated conditions in such a cold and dry climate, unless the humidity is specifically controlled (e.g. by using humidifiers). The humidity in the building was found to become particularly low after mid-December, fluctuating

Figure 9 Vertical movement of glulam column, PSL beam, and combined column and beam at Location 1

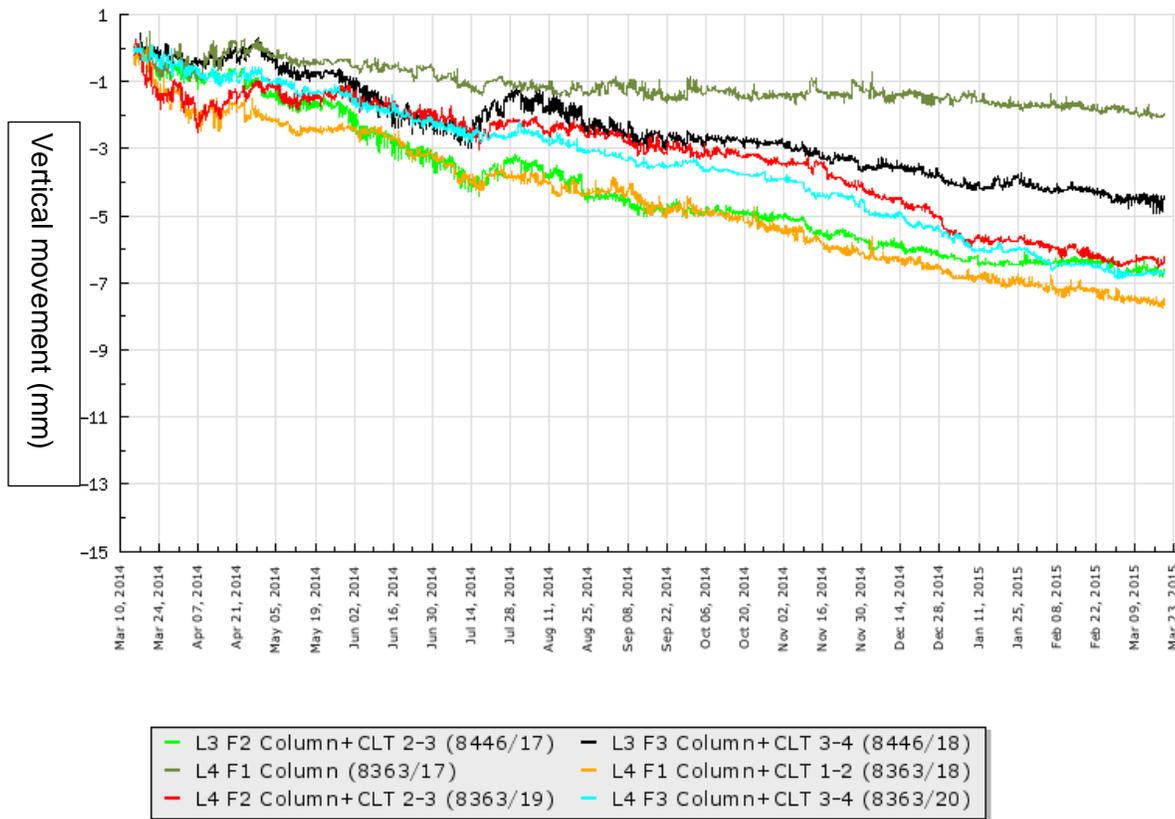
When a measurement covered a glulam column, a CLT floor, and the connection between them, the movement amount increased greatly (Figure 10, Table 5). The floors of this building were built with two layers of vertically staggered CLT panels, which were structurally supported by glulam beams at each end. The glulam beams were supported by glulam columns using dovetail connections. It is believed that the beam should have a minor contribution to the vertical movement measurement since its vertical movement (including shrinkage) is restrained by the column and the connection. Being 5-ply and 169 mm thick, the bottom CLT panel was included in the corresponding measurement with a displacement box installed to sit on this panel (i.e., in the space created by the staggered CLT floor panels, right next to the supporting glulam column). The CLT panels are not major members for bearing gravity loads in this building and there should be no cumulative deformation resulting from compression. Similarly, the panels may deflect under loads, particularly over a large span, but that would not contribute to any vertical movement measured in this study. Shrinkage of the CLT panel (out-of-plane) resulting from drying must therefore be a major reason for the measured movement at each location. It was mentioned above that the sensor labelled "L4 F1 Column" showed a shortening amount of 1.8 mm. For comparison, the displacement sensor labelled "L4 F1 Column+CLT 1-2" showed a total shortening of 7.3 mm. These two sensors were installed from the bottom of the same glulam column, but the former ended at the upper end of the column (i.e., measuring only the glulam column) and the latter extended above the CLT floor (i.e., covering the glulam column, the CLT floor, and part of the glulam beam). This indicates that the difference of 5.5 mm between these two measurements was primarily caused by shrinkage of the CLT floor panel. The shrinkage for out-of-plane CLT can be estimated when the MC change and shrinkage coefficient are known. The CLT panels have a MC of $12 \pm 2\%$ at time of production based on information from the manufacturer (<http://structurlam.com/products/cross-laminated-timber/>). When the field monitoring started in March 2014, the average MC of the panels was estimated to be 13% based on measurements using a portable capacitance moisture meter at the site

Figure 10 Vertical movement of glulam column and combined column and CLT floor at Locations 3 and 4

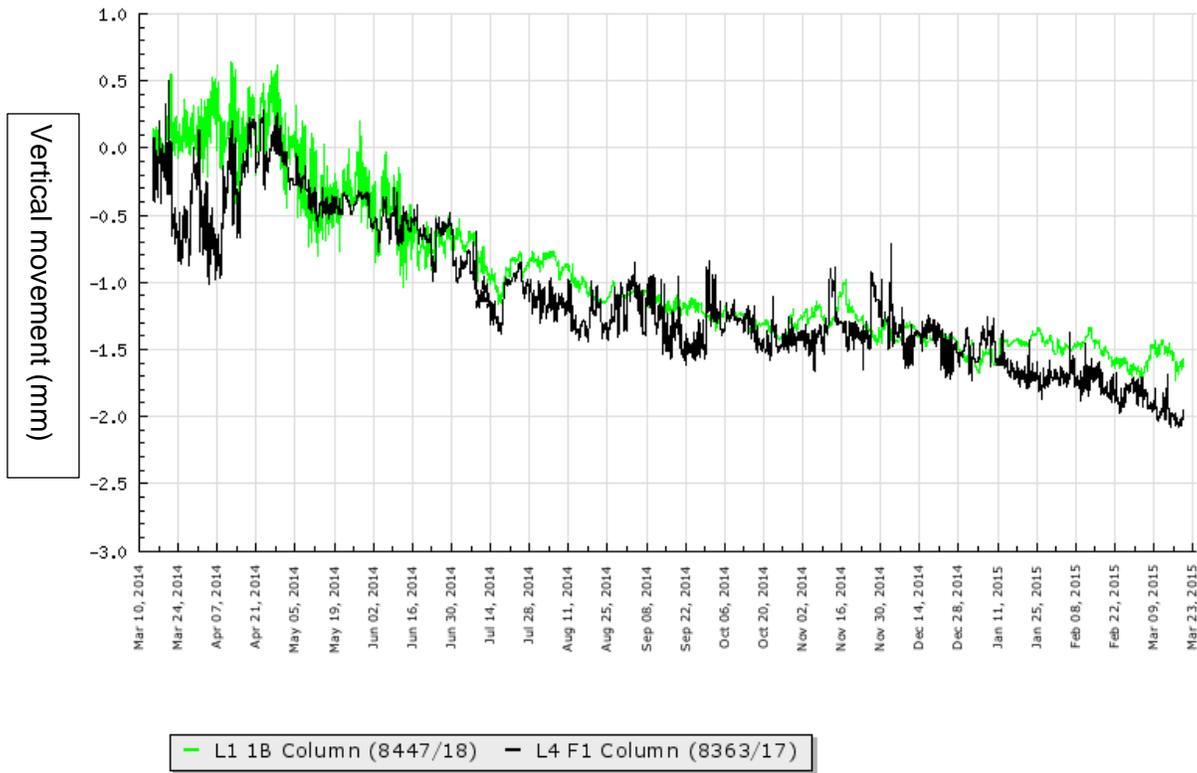
At Locations 3 and 4, the behaviour of the glulam column measured by the sensor “L4 F1 Column” was very consistent with the glulam at Location 1, with the maximum shortening of about 1.8 mm (Figures

Figure 11 Vertical movement of two glulam columns at Locations 1 and 4

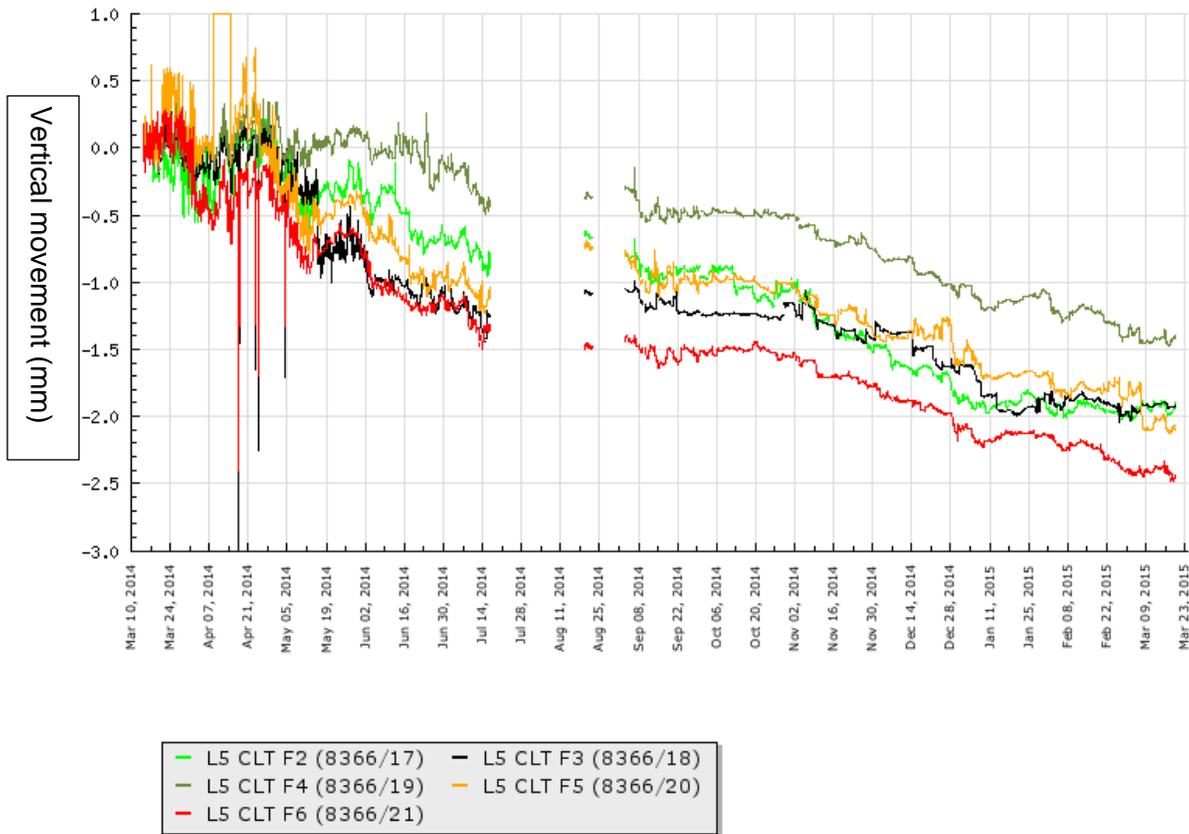
According to the drawings, the CLT walls in this building have a height of 24.5 m, with two horizontal step joints. The vertical movement was only partially monitored from the 2nd floor to the 6th floor, as described in Section 5.3. Similar to the measurements of the two glulam columns at Locations 1 and 4, the shortening amounts measured from the CLT wall were also found to be small, ranging from 1.3 mm to 2.3 mm on each floor (Figure 13, with the service environmental conditions shown in Figures 14 and 15). The measurements in this study confirmed that CLT was also highly dimensionally stable in its plane direction. Assuming that wood shrinkage and load-induced deformation were uniform along the height on each floor, and the movement amounts were proportional based on of the heights of the wall, the measurements showed that the total shortening of the CLT wall, from Floors 1 to 6, would be about 14 mm. This is larger than the vertical movement of a glulam line under the same indoor environment but the differential movement is quite small for such a building.

Figure 13 Vertical movement of CLT wall from Floors 2 to 6 at Locations 5

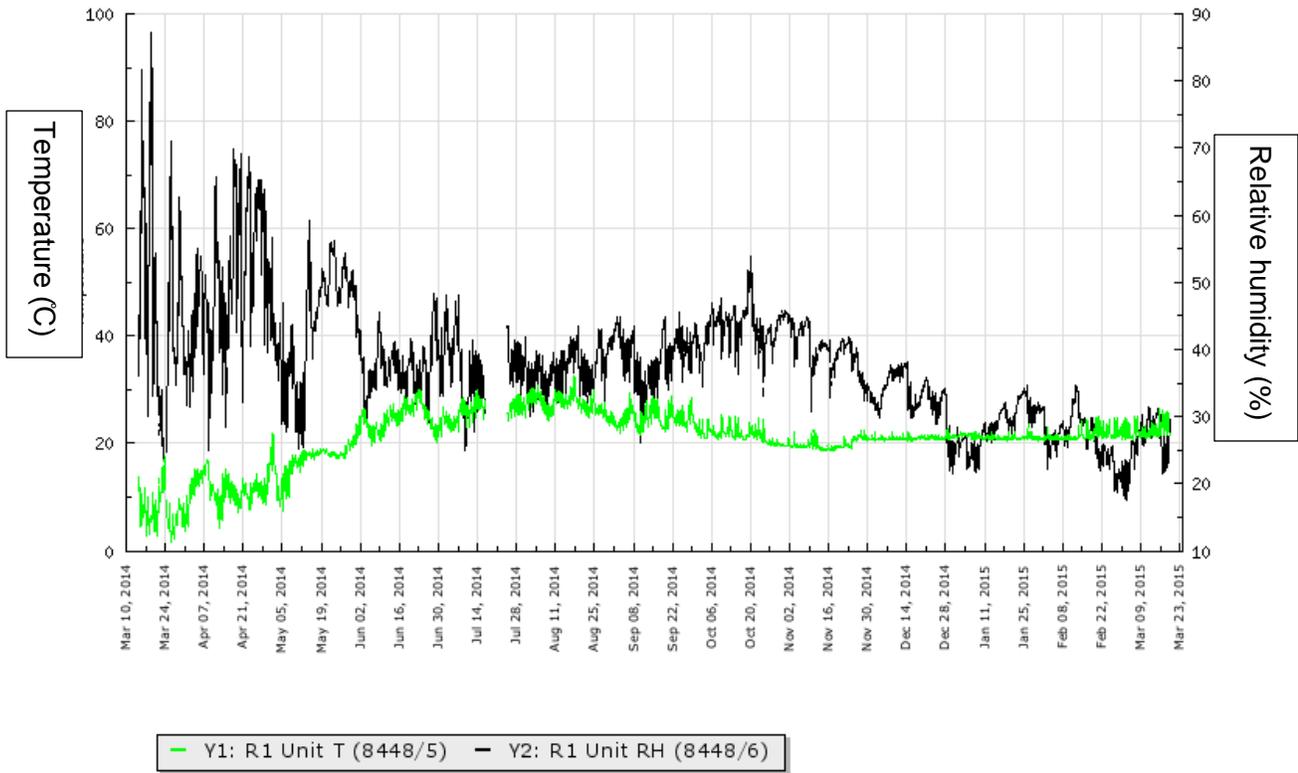
The wood roof structure was generally very dry during this monitoring period. Figure 16 shows RH and temperature measured from Location R1 to represent environmental conditions in the roof area. Consistent with the ambient conditions measured from areas closer to the walls, most locations of the roof showed RH below 50% in the summer of 2014, and the humidity reached very low levels in December 2014. As a result of the dry indoor environment, both the plywood roof sheathing (Figure 17) and the CLT panels below (Figure 18) produced very low MC readings at these five monitoring locations (i.e., except R4). It should be noted that the resistance-based measurement systems showed a lower MC limit of 11% in this study, with calibration based on lodgepole pine (due to the use of “SPF” CLT and plywood sheathing). Therefore a reading of around 11% may not reflect the real wood MC. The electrical resistance becomes too high to be accurately measured when the wood MC is too low. The sheathing of a flat roof would be typically subjected to the highest risk when wetting occurs during

Figure 16 Relative humidity and temperature at Roof 1 location

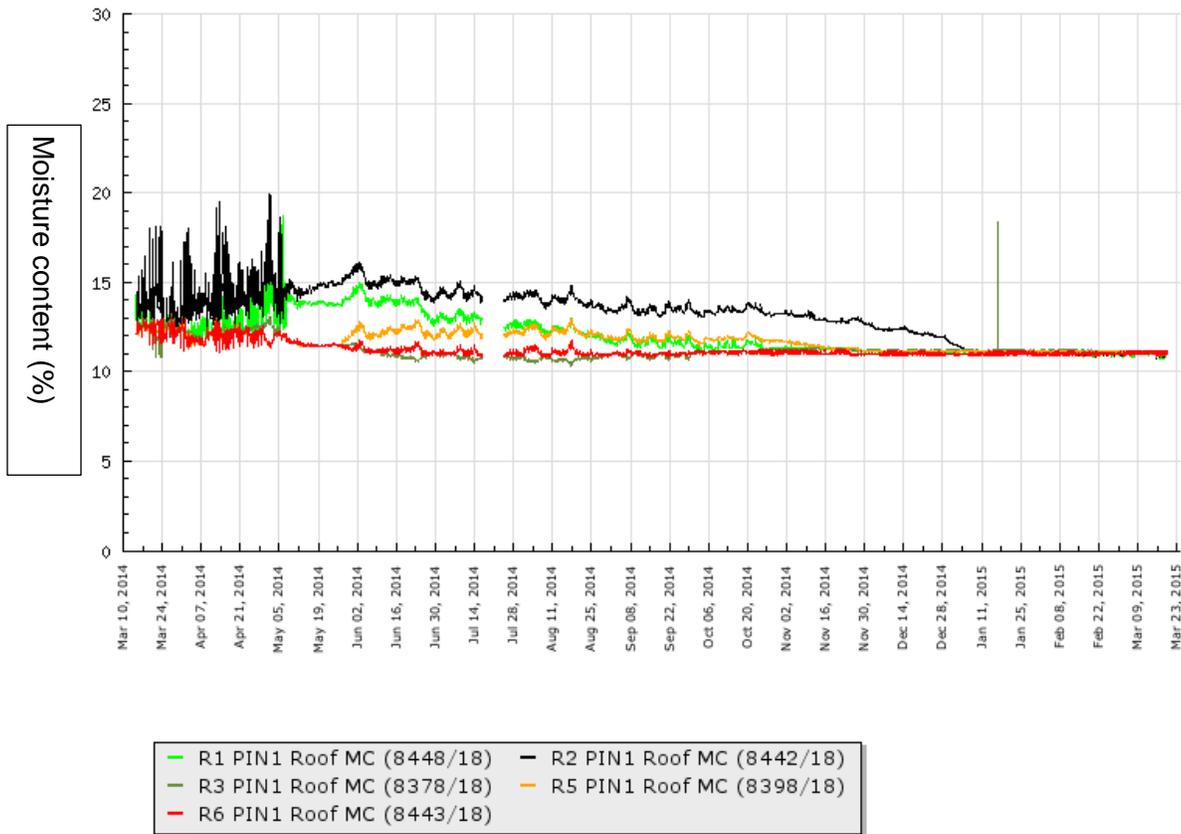
For the R4 location, the instruments were not installed until July 2014 due to construction activities. Once the system was activated, the MC of the plywood sheathing at that location was found to be about 25%, the highest MC detected in this study since the monitoring program started. The high initial MC must have been caused by the pouring of the wet concrete layer above the plywood sheathing. This finding was immediately sent to the contractor as an alert; however, there should be no further moisture imposed on the sheathing after the roofing membranes were installed. Also, the monitoring showed that the plywood sheathing gradually dried with the MC gradually dropped to 20% in September and to 15% in January 2015. In addition to this suspected leak at R4, it was found that the humidity level in the ventilation gap, i.e., between the roof sheathing and the CLT beam at the R3 location, reached almost 100% during the construction period in March 2014. Again the monitoring showed that the humidity readings gradually dropped and remained around 60% in June 2014. Coincidentally a concrete layer was also installed above the plywood sheathing at this location. In general, the roof showed good drying performance. The design also facilitated detection of water leaks. Both are important for the long-term durability of a mass timber roof.

Figure 17 MC measured from plywood sheathing at five roof locations
