## MONITORING OF HISTORIC STRUCTURES FOR WHOLE BUILDING IMPROVEMENTS

### ABSTRACT

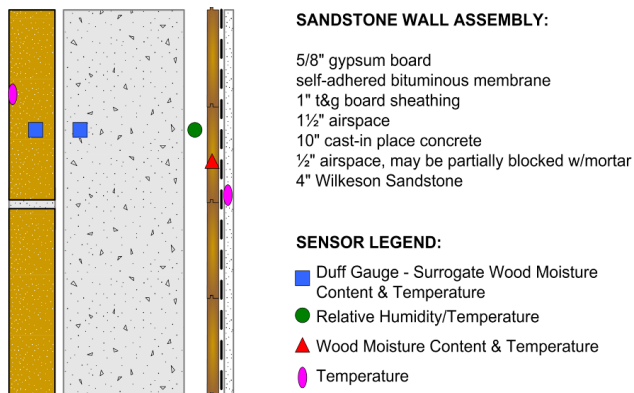
The existing sandstone wall assembly and location of the installed sensors is shown in Figure 1. The installed sensors include the following:

Figure 1. Existing Sandstone Wall Assembly and Installed Sensors

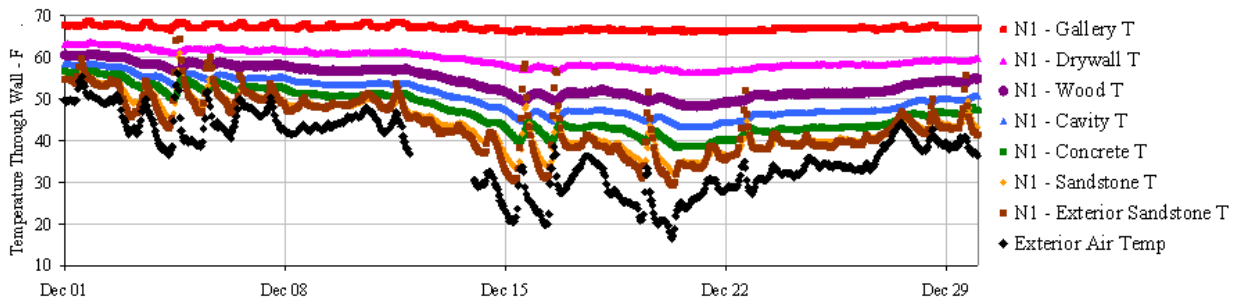
Measured temperatures throughout the west facing sandstone wall assembly at the north exhibit space (N1) are plotted in Figure 2 for December 2008, when Seattle experienced record low temperatures and snow accumulation. The measured temperatures at the N1 exhibit space location are representative of typical conditions for the sandstone wall assemblies.

Figure 2. Temperature Profile through West Facing Sandstone Wall at North Gallery, December 2008

Temperatures throughout the mass wall remain more consistent, only slightly affected by daily temperature swings. At the coldest time of the year (<20°F exterior temperatures), the surface of the sandstone drops down to only slightly below freezing, 29-30°F. Depending on the saturation level of the surface of the sandstone, it could be susceptible to freeze-thaw damage. Based on a review of the sandstone façade, freeze-thaw damage does not appear to be an issue, nor is freeze thaw damage typically an issue in Seattle's temperate climate.

Interior wall surface temperatures are much lower than interior air temperatures, with a maximum wintertime difference of

approximately 10°F. As a result of the lower temperatures, the RH level at the wall surface will be higher than the exhibit space, and conditions behind artwork may be conducive to organic growth (>80% RH moderate risk to >95% high risk). If the wall surface temperature drops below the exhibit space air dew point temperature of approximately 50°F (the maintained indoor dewpoint at 70°F and 50% RH), then condensation is likely to occur. Interior wall surface temperatures are compared for four sandstone wall locations monitored at the south and north exhibition spaces and are plotted in Figure 3 for the coldest period in December at gallery space S7.

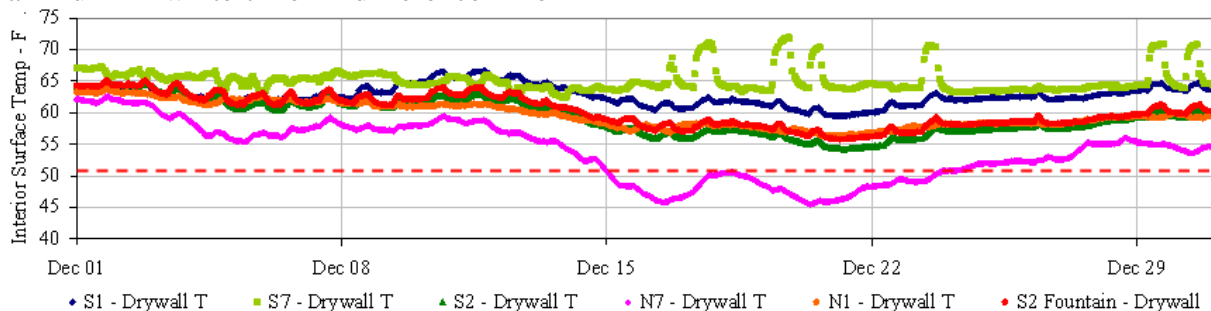
Figure 3. Interior Wall Surface Temperature of Monitored Exterior Walls; Worst Case December 2008 Conditions

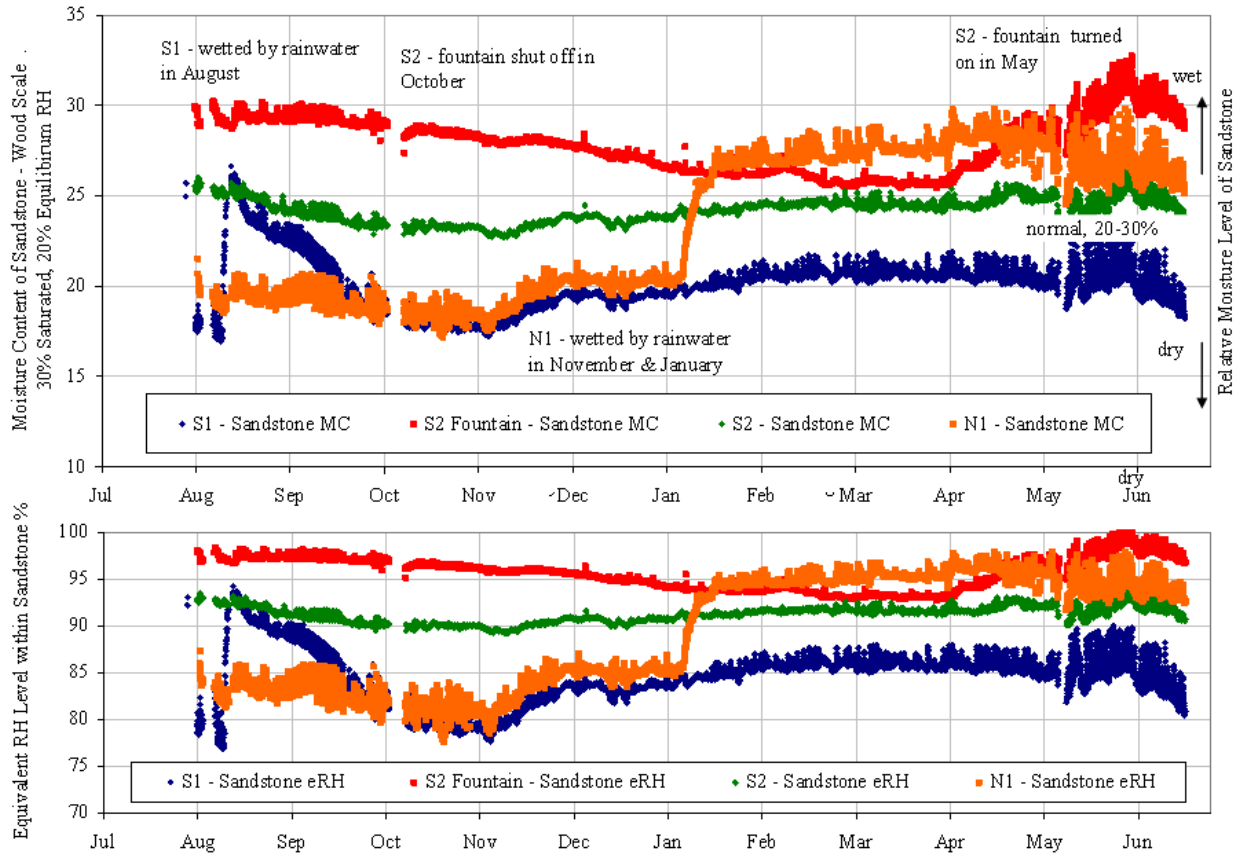
By using surrogate moisture content sensors, the RH level was measured within the sandstone near mid-depth, 2" to 2 1/2" from the exterior surface of the 4" thick panel. The measured wood moisture content and calculated RH levels within the sandstone from July 2008 through June 2009 are provided in Figure 4. The calculated RH levels within the concrete behind the sandstone veneer are presented in Figure 5. Figure 6 presents the calculated driving rain

Figure 4. Measured RH within Sandstone Veneer at Mid-depth: July 2008 through June 2009

The RH and subsequent moisture levels within the sandstone and concrete remain fairly consistent throughout the monitored period and are at normal levels. As expected, the sandstone and concrete at the S2 exhibit fountain remains the highest as a result of the continuous wetting from fountain water splash back against the wall (Figure 5). When the fountain is shut-off in October the sandstone dries slowly over the winter, until the fountain is turned back on again in May. The moisture levels within the stone and concrete near the fountain are indicative of worst case conditions for the sandstone façade.

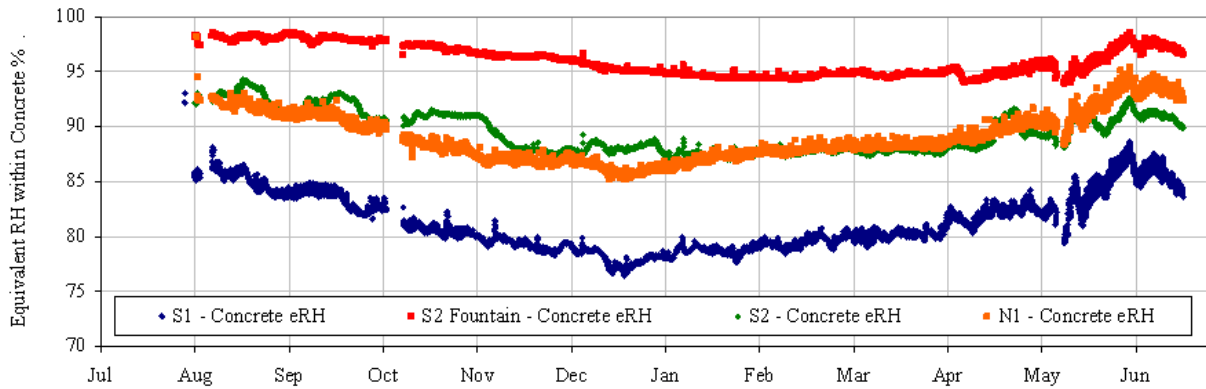
Figure 5. Measured RH within Concrete, directly behind Sandstone Veneer; July 2008 through June 2009

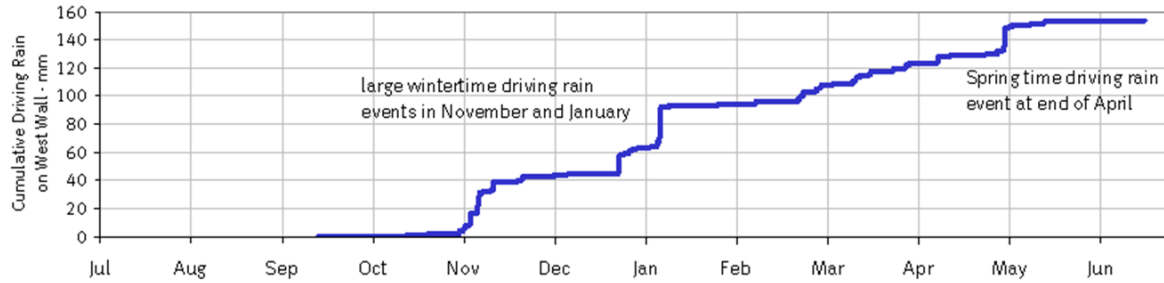
Figure 6. Calculated Driving Rain on West Facing Sandstone Façade: September 2008 through June 2009.

The moisture levels within the exposed west facing sandstone veneer remain fairly consistent, however following large driving rain events in November and January (as shown in Figure 6) the monitored locations at exhibit S1 and N1 (exposed at west elevations) are both wetted significantly, resulting in an increase in the overall sandstone moisture content, up to similar levels caused by the fountain.

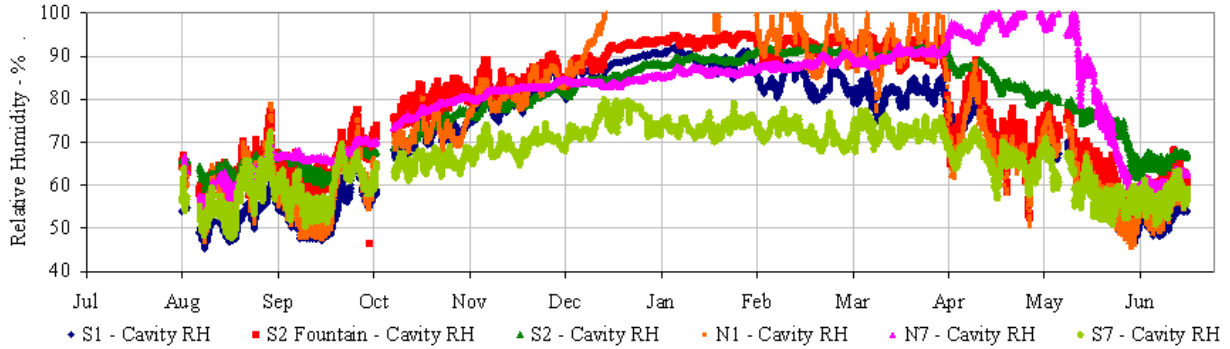
Figure 7. Relative Humidity within Cavity between Concrete and Wood Sheathing Boards: July 2008 through June 2009.

The relative humidity within the cavity between the concrete and board sheathing elevates during the winter months. Consequently, the moisture content of the board sheathing elevates in most locations above fiber saturation. The four sandstone wall locations are noticeably much wetter than the exposed concrete or concrete block assemblies. The sandstone wall assembly contains a vapor barrier on the interior side of the board sheathing, which blocks vapor diffusion towards the interior and prevents the wood from drying. The wall assemblies at exhibit N7 and S7 (exposed concrete and concrete block) do not have a vapor barrier and thus allows the wood to dry towards the interior.

Exterior leaks and vapor diffusion were ruled out as primary wetting mechanisms, leaving interior air-leakage into the cavity

between the wood sheathing and concrete as the source of moisture wetting the sheathing. Measured temperatures through the sandstone wall assemblies indicate that concrete and wood surface temperatures within the cavity are between 10 and 20°F colder in winter than the interior air (Figure 2), as the wood sheathing and drywall are relatively insulating in comparison to the concrete and sandstone. The temperatures within the cavity are also at or below the dew point temperature of the exhibit spaces. As a result, when warm moist air from the exhibit area enters the cavity the RH level rises, contributing moisture to the porous concrete and wood surfaces via adsorption. When temperatures within the cavity warm up in the spring, the accumulated moisture evaporates and is removed by airflow through the cavity.

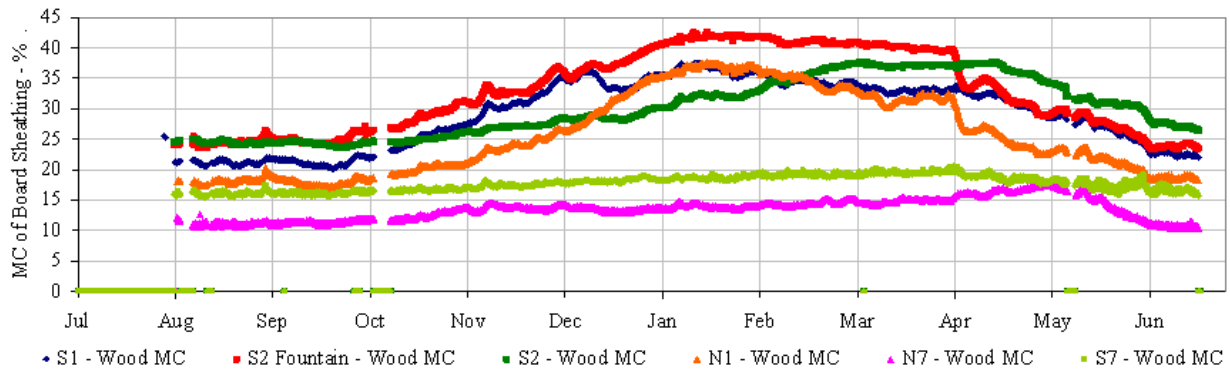
Figure 8. Moisture Content of Wood Sheathing Boards: July 2008 through June 2009.

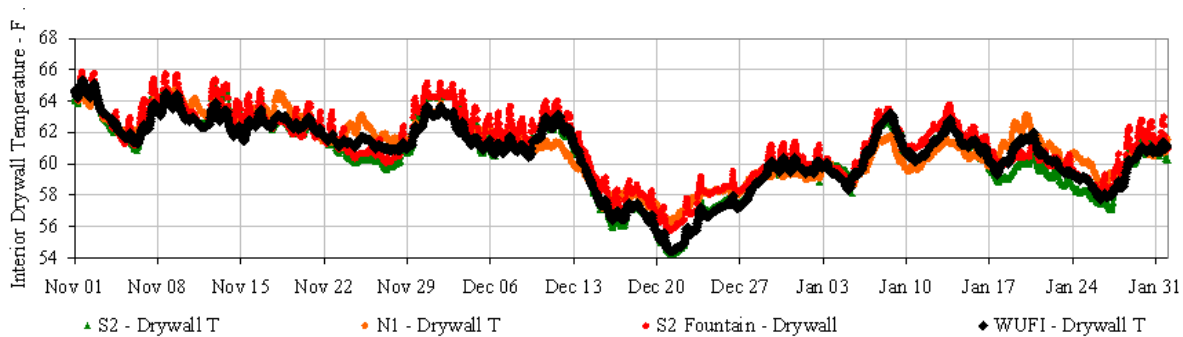
The simulations performed found that the WUFI model accurately approximated both the measured moisture and thermal performance of the sandstone wall assemblies. Of most concern for the analysis are the moisture levels and temperatures of the sandstone for freeze-thaw assessment, and the interior wall surface temperatures for condensation risk assessment. Figure 9 compares the modeled to the measured interior drywall surface temperature for a 2-month period during the winter. Small variations are observed between the model and measurements, but the hourly trends are well captured within  $\pm 2^{\circ}\text{F}$ .

Figure 9. Measured versus WUFI Modeled Interior Drywall Surface Temperature, November 1, 2008 through February 1, 2009

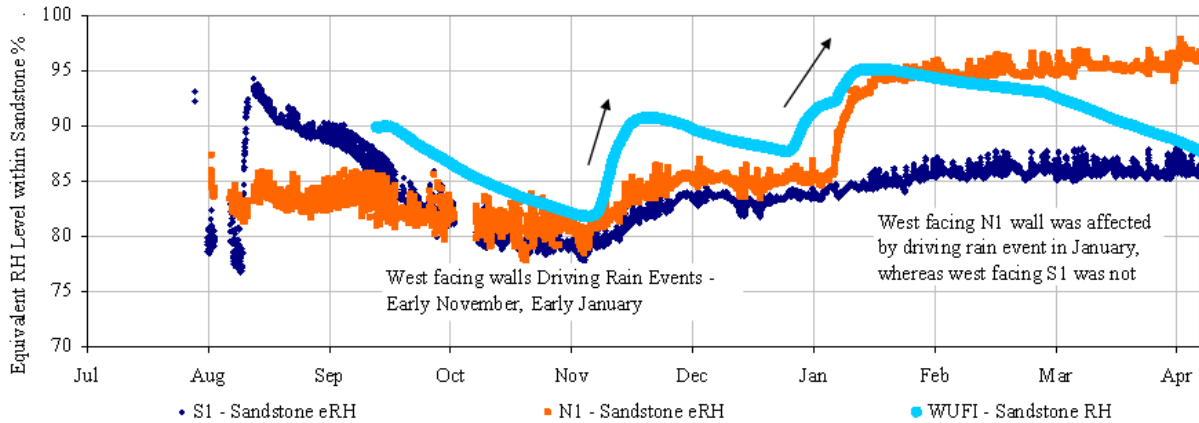
WUFI is also able to approximate the moisture levels with the sandstone; however small variations between the modeled and measured data are observed (Figure 10). These differences largely appear to be the result of variable driving rain rates on the sandstone surface. Both locations appear to receive less than the amount predicted by WUFI. Absorption of water into the

sandstone will also vary by location, as will absorption of water into the surrogate moisture content sensors. Overall the modeled RH within the sandstone provides a conservative estimate of its performance and likely representative of an exposed location near the top of the building which receives more driving rain.

Figure 10. Measured versus WUFI Modeled RH level within Sandstone at West Facing Sandstone Wall Assembly

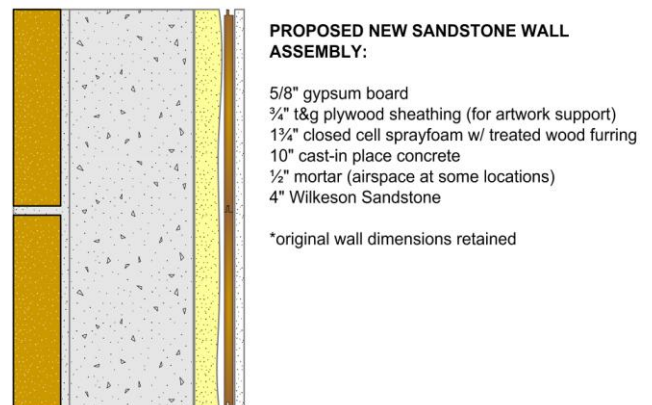
Figure 11. Proposed Sandstone Wall Assembly

To improve the thermal performance of the sandstone wall assembly without removing the sandstone from the exterior, it is proposed that insulation is added to the interior of the wall assembly. The proposed wall sandstone wall assembly with the addition of 1 ¾" of closed-cell sprayfoam (R-10.5) is shown in Figure 11.

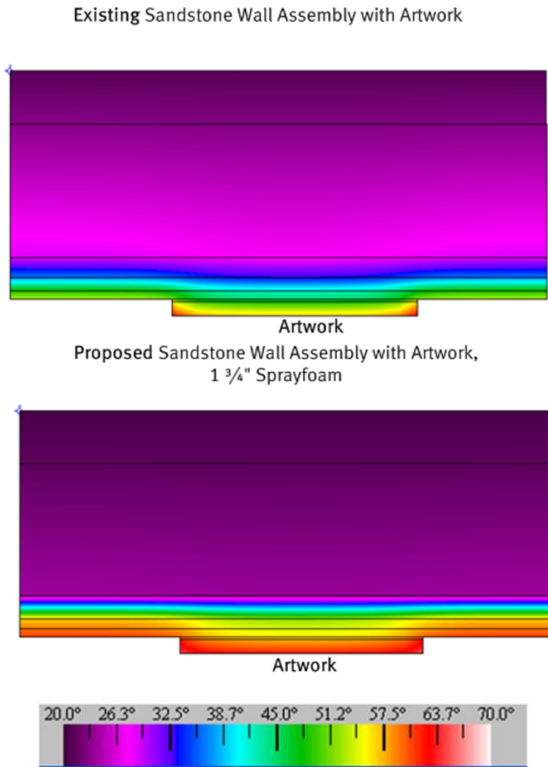
As shown in Figure 12, the interior surface of the insulated wall assembly is significantly warmer than the uninsulated wall, especially behind the artwork. Surface temperatures in the insulated wall are much

higher than the air dew point temperature, reducing the potential for condensation.

Figure 12. Plan view of existing and proposed wall section showing temperature profile of wall assembly

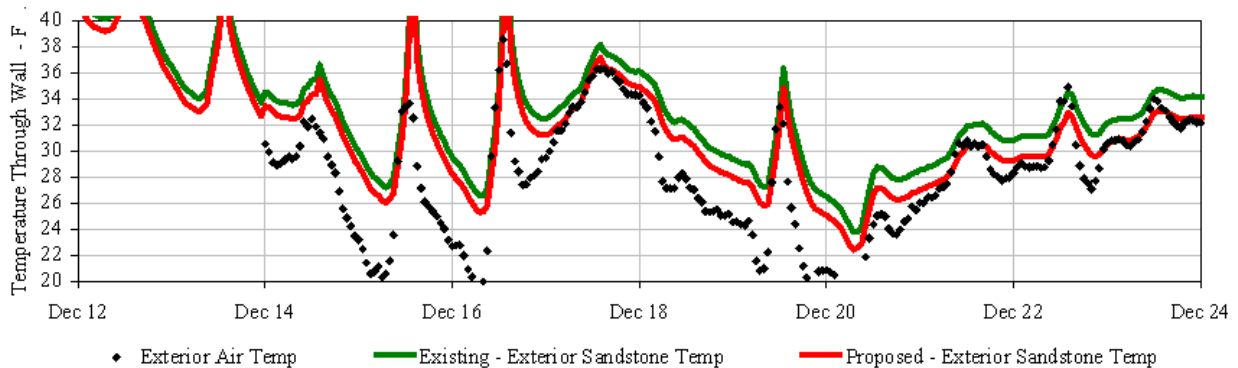
One of the potential risks associated with insulating the interior of masonry or stone wall assembly is the possible increase in risk of freeze-thaw related damage to the sandstone surface. While rare in Seattle's climate, the analysis was performed as a precaution. Freeze-thaw damage can occur when the surface of the sandstone is near saturation (typically 80% of saturation) and drops below freezing and thaws. Depending on the properties of the stone, spalling may occur. No evidence of spalling caused by freeze-thaw damage was observed on the sandstone façade during our review. Using WUFI, it was confirmed that the number of freeze-thaw cycles the sandstone surface sees in a typical year when saturated is zero (Figure 13). The number of hours that the wall assembly spends below freezing is increased from 123 to 155 hours when simulating 2008 winter data, but no freeze-thaw cycles at critical saturation levels are observed. Therefore the interior insulated sandstone wall assembly does not appreciably increase the already low risk for freeze-thaw damage to the sandstone. Other factors as previously discussed with the sandstone material itself are more likely to cause spalling than freeze-thaw damage.

Figure 13 Temperature Profile through West Sandstone Wall at Gallery N1
