# FIELD MONITORING OF HYGROTHERMAL PERFORMANCE OF ATTIC VENTING SYSTEMS IN EXTREME COLD CLIMATE

#### ABSTRACT

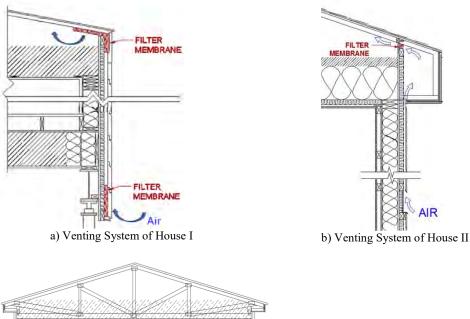
House III is a two-story house built in Iqaluit, Nunavut in 2012, consisting of two 157 m2 (1700 ft2) units with a shared mechanical room. This house is a prototype SIP house that has the potential to be used to rapidly construct durable, energy efficient homes for the housing shortage. This passive system uses an unventilated cold roof (Figure 2c), which relies on an airtight ceiling assembly that will keep the warm moist interior air from entering the unconditioned attic space. The unventilated attic means that there is no chance of fine snow particles infiltrating the attic space from outside, if built properly. However, extensive research has also not been conducted on this type of attic system to determine whether it will have sufficient drying potential and will be suitable for the extreme northern climates.

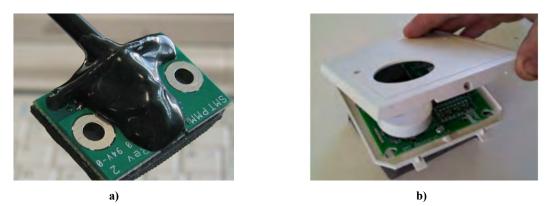
Figure 3: a) Moisture Content Sensor and b) Wireless Multi-Channel Data Logger

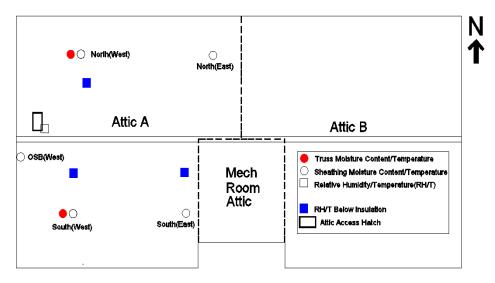
Figure 5: Sensor Locations in the Attic of House I

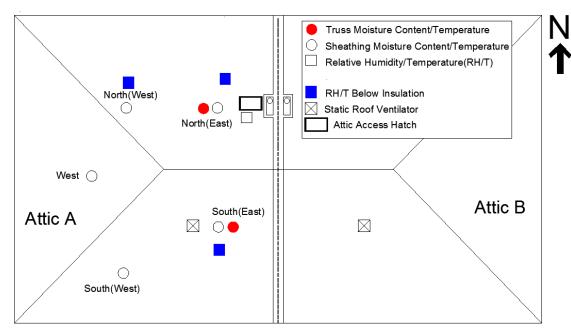
Figure 7: Sensor Locations in the Attic of House II

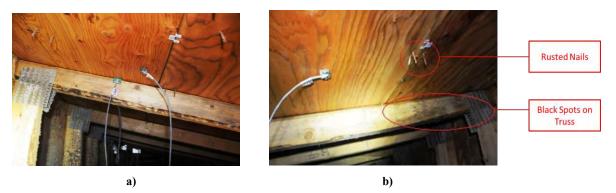
Figure 8: Field Observation in the Attic of House III: a) Wet Plywood Sheathing; b) Rusty Nails and Black Spot on Truss

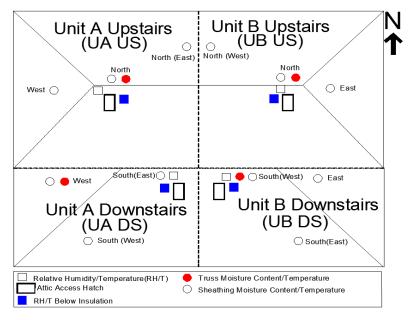
Figure 9: Sensor Locations in the Attic of House III (SIP Unventilated)

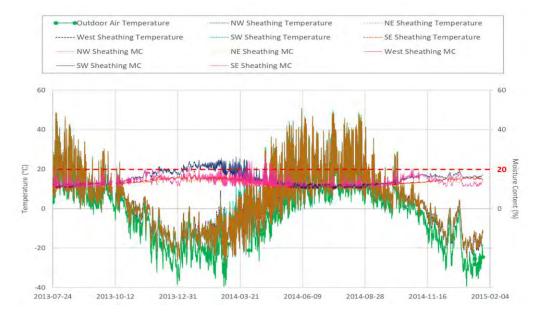
Figure 10: Moisture Content and Temperature of Plywood Sheathing in House I Measured During the Monitoring Period from July 2013 to January 2015

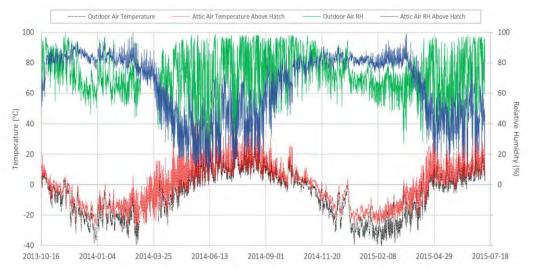
Figure 11: Attic Air RH/T in House I Compared to Outdoor Air RH/T

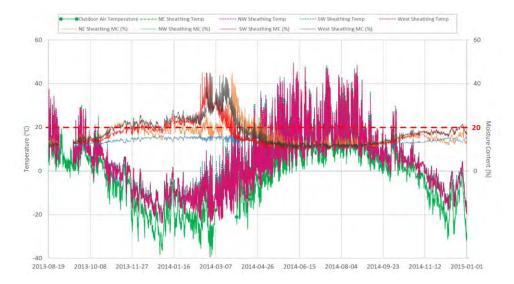
Figure 12: Moisture Content and Temperature of Plywood Sheathing in House II Measured During the Monitoring Period from Aug. 2013 to January 2015

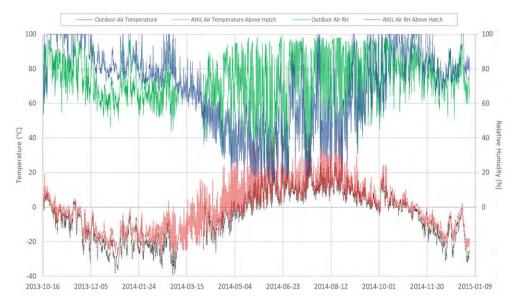
Figure 13: Attic Air RH/T in House II Compared to Outdoor Air RH/T

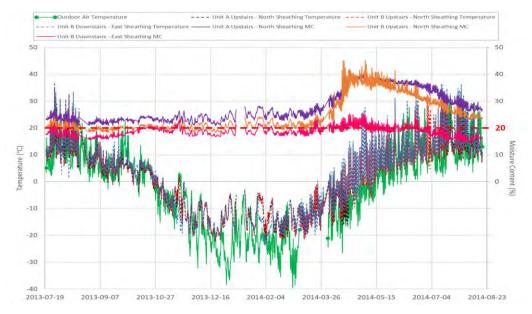
Figure 14: Moisture Content and Temperature of Plywood Sheathing of House III Measured During the Monitoring Period from July 2013 to Aug. 2014

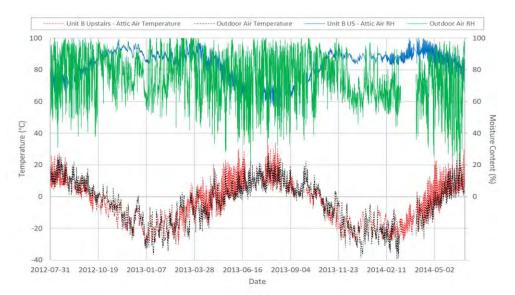
Figure 15: Attic Air RH/T in Unit B Upstairs in House III Compared to Outdoor Air RH/T
