MOISTURE PERFORMANCE AND VERTICAL MOVEMENT MONITORING OF PRE-FABRICATED CROSS LAMINATE TIMBER – FEATURED CASE STUDY: UBC TALLWOOD HOUSE

G. Mustapha, K. Khondoker, J. Higgins

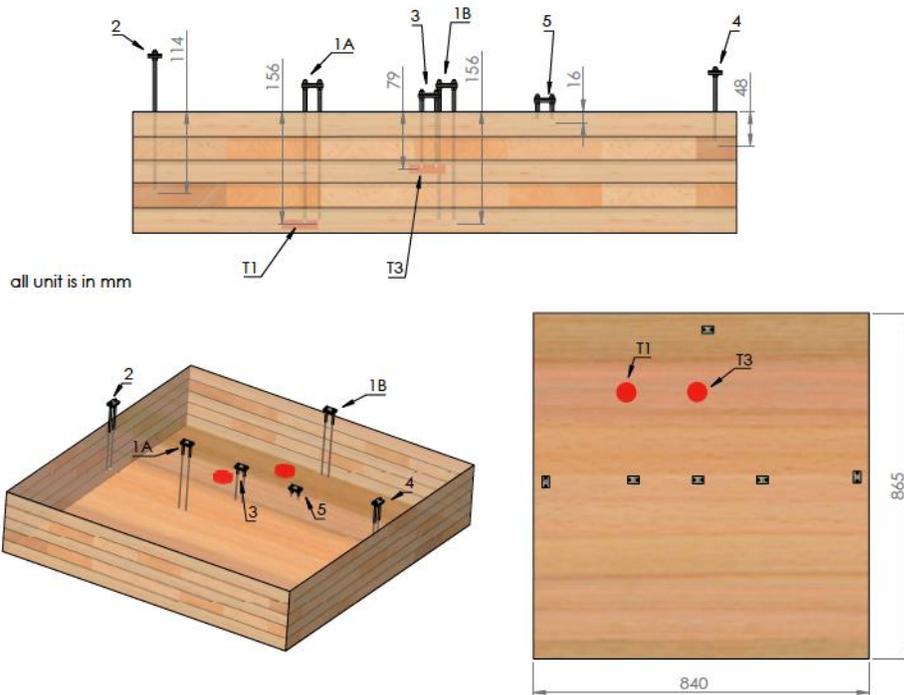
Detailed in Figure 2 a number system corresponding with drill depth was developed with #1 being the midpoint of the topmost layer and #5 being the depth of the bottom ply. Depths 1 and 2 utilized 200mm probes, depths 3 and 4 110 mm probes, and 5 a 40mm probe. Thermistors were installed to depth 3 at the center of the panel, and to depth 1 at the top face.

The CLT panel grain orientation changes with each layer. Probes were installed parallel to the grain of the testing layer to gather consistent data.

Figure 2: Probe Locations and Orientation

Moisture probes were installed into the CLT panels in the Tallwood House onsite at UBC. Point Moisture Measurement Sensors (PMMs) were installed in alternating East-West and North-South panels on every second floor. The orientation of the PMMs and their depths were installed identically to the transportation study as illustrated in Figure 2.

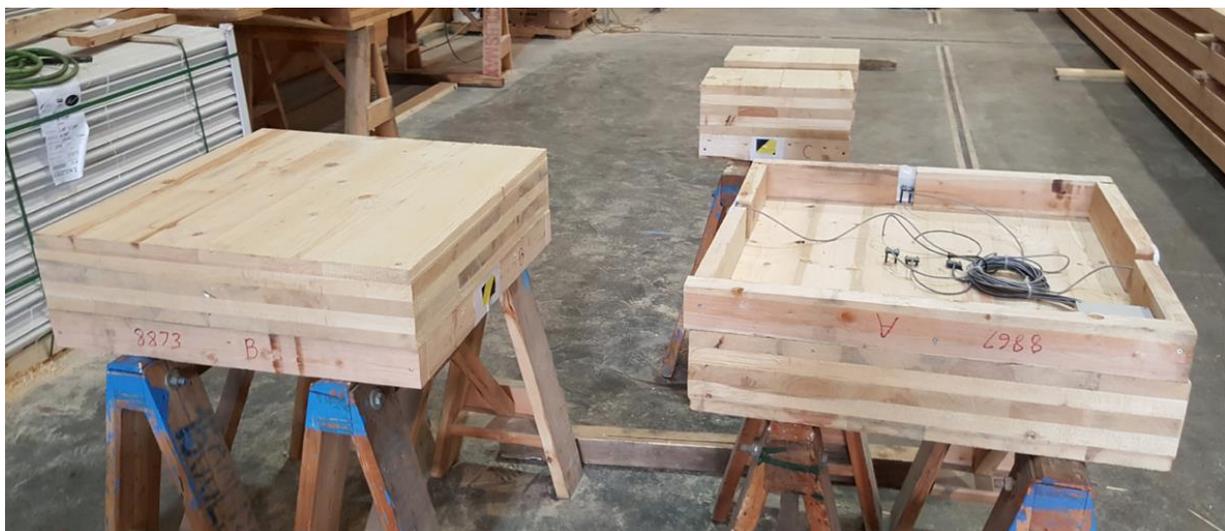
Figure 3: Instrumented Off-cuts – May 7th, 2016-06-01

During the first trip, 2 large offcuts were outfitted with sensors, as well as 2 smaller CLT blocks. During the second trip, 6 large offcuts were instrumented and stored. All offcuts were coated with the same products and in the same manner as the full-size floor panels. The offcuts were then wrapped in plastic, stacked and stored alongside the full-size panels. Wood slats were placed in between each panel to increase airflow to the panels and prevent any potential moisture buildup, similar to how the full-size floor panels were stored.

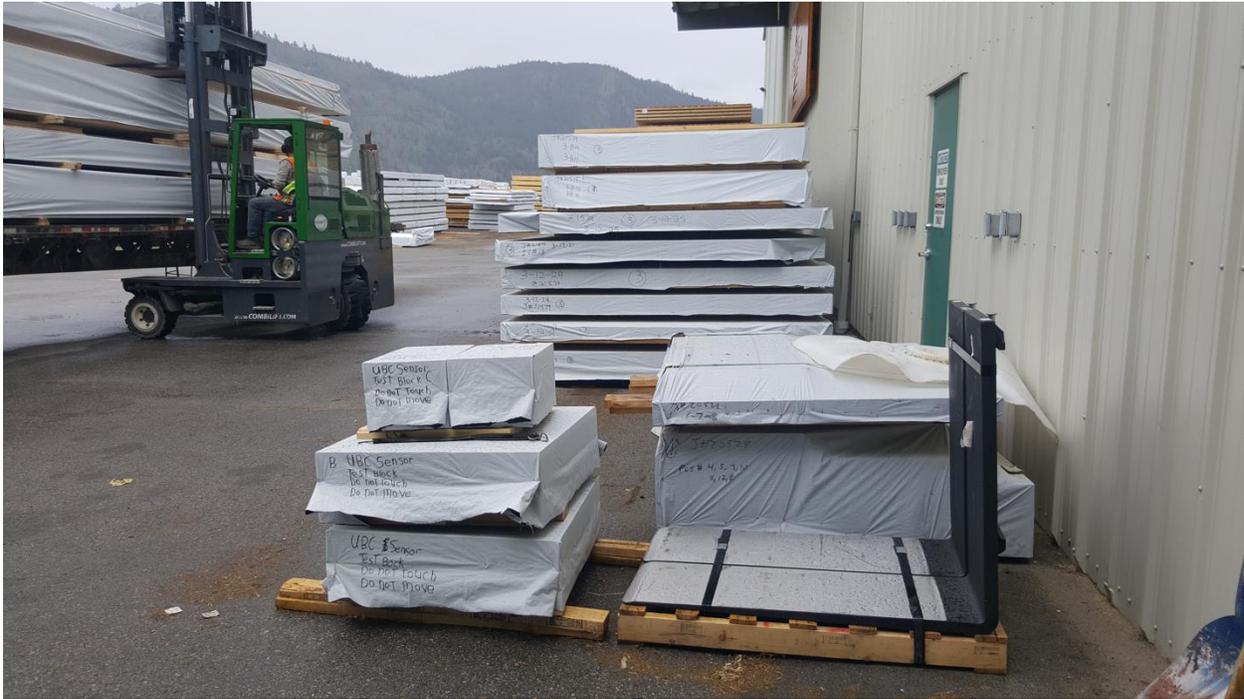
Figure 4: Off-cuts Stored outside alongside full size CLT panels

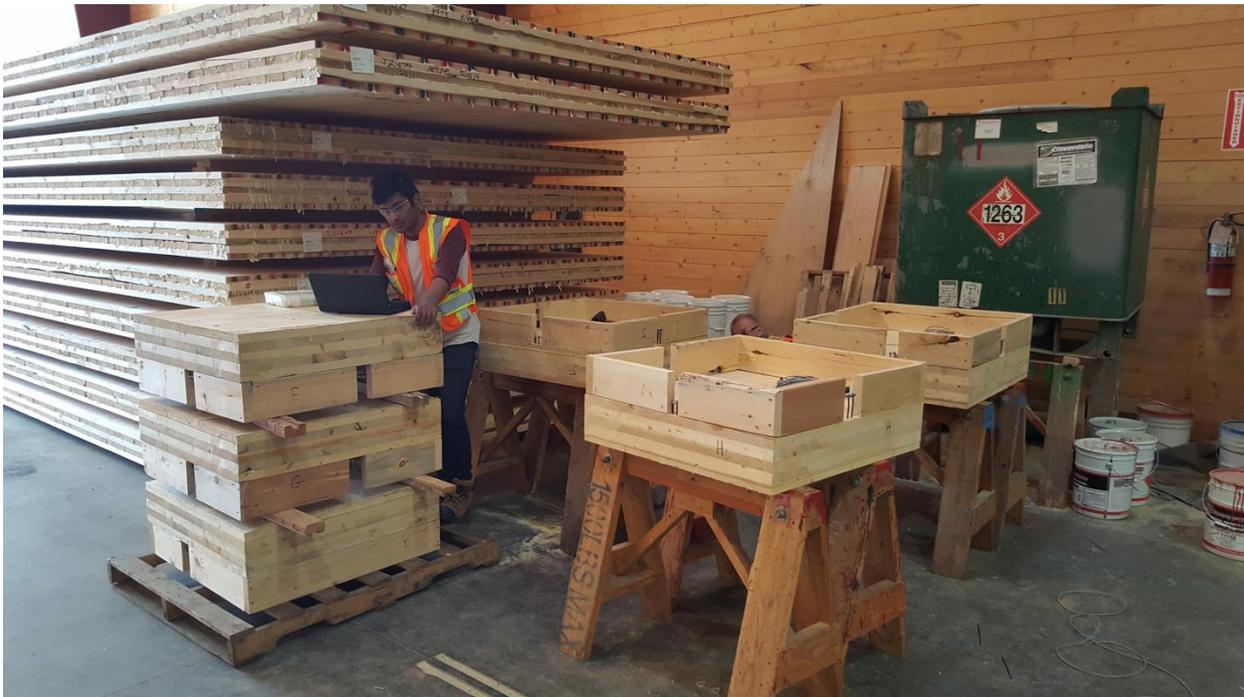
Figure 5: Six additional off-cuts were instrumented on May 27th, 2016-06-01

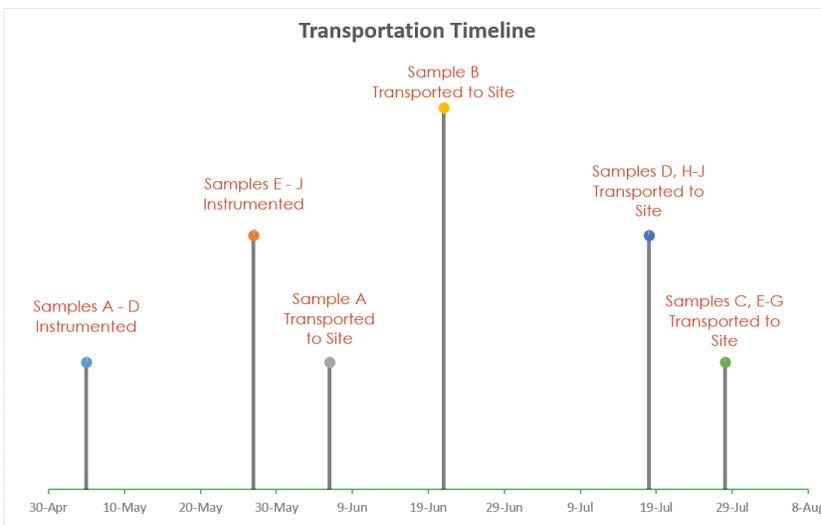
The timeline and path of travel for the transportation CLT samples are as shown in Figure 6 and Figure 7 below. Samples were shipped with different floor panel shipments to create a diverse set of data with the possibility of varying environmental and logistical conditions.

Figure 6: Transportation Timeline of Samples

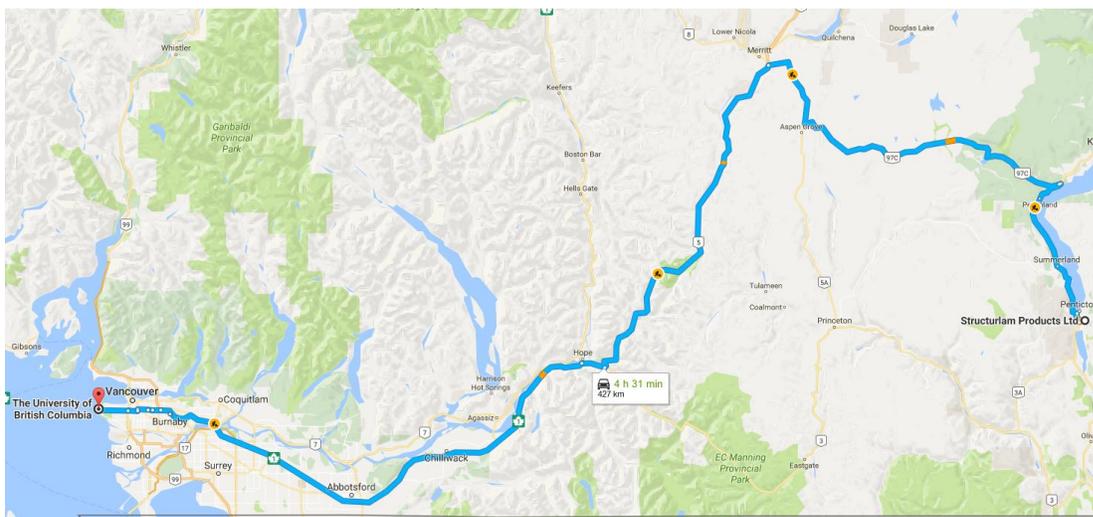
Figure 7: CLT Path to Site

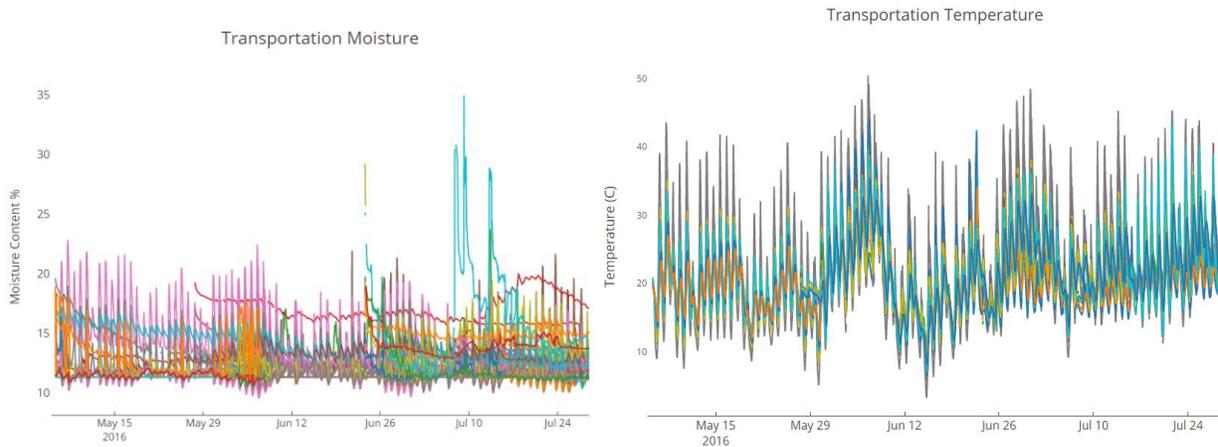
Moisture and Temperature data were collected by the wireless data loggers connected to each panel. These devices stored data regardless of where the sample was located and transmitted the data to the Internet upon arriving on-site. Results from 60 moisture content sensors at varying depths and 20 temperature sensors are shown in Figure 8.

Figure 8: Transportation Moisture and Temperature Data

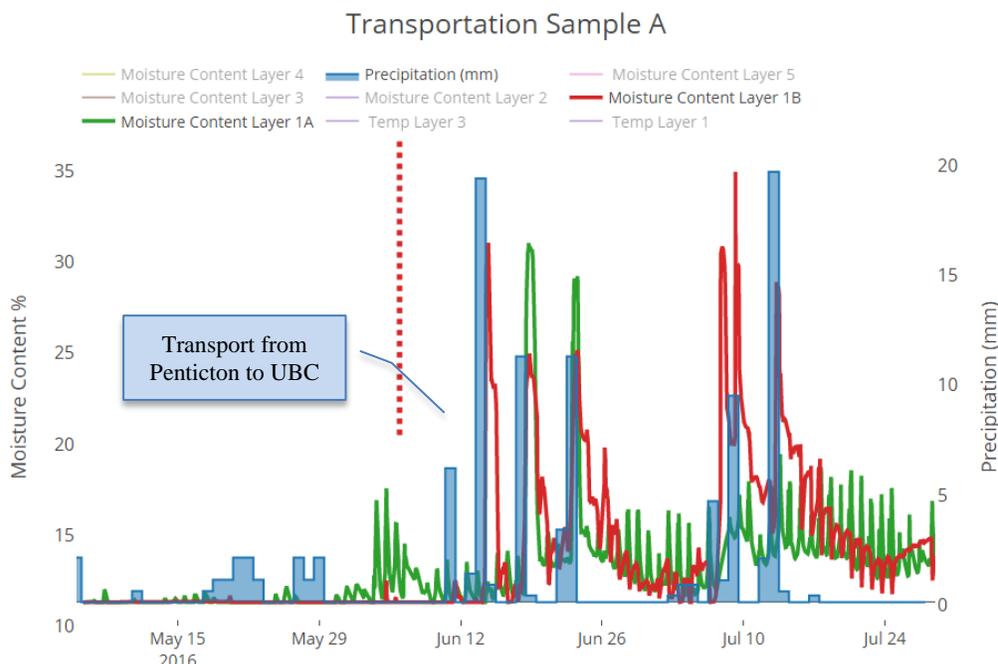
Data from Transportation Sample A which arrived and was uncovered to reflect the conditions of the CLT of the structure showed the effectiveness of the processes the CLT manufacturer implemented while storing and transporting the CLT panels for this project. As seen in Figure 9 prior to shipping, moisture levels in

Figure 9: Analysis of Sample A during Transport

the CLT samples stayed very consistent and were did not appear to be exposed to moisture.

Once uncovered and exposed to a series of rainfall events, the effects can clearly be seen in a spike of moisture levels in the topmost layer of the sample. Data from the top layer of CLT is shown in Figure 9 with the dotted red line indicating the day of transport from Penticton to the building site at UBC. The rapid decrease of sample moisture demonstrated the drying ability of the fully-exposed CLT. These observations of the CLT are consistent with observations which were made in later analysis of the in-building moisture levels during construction.

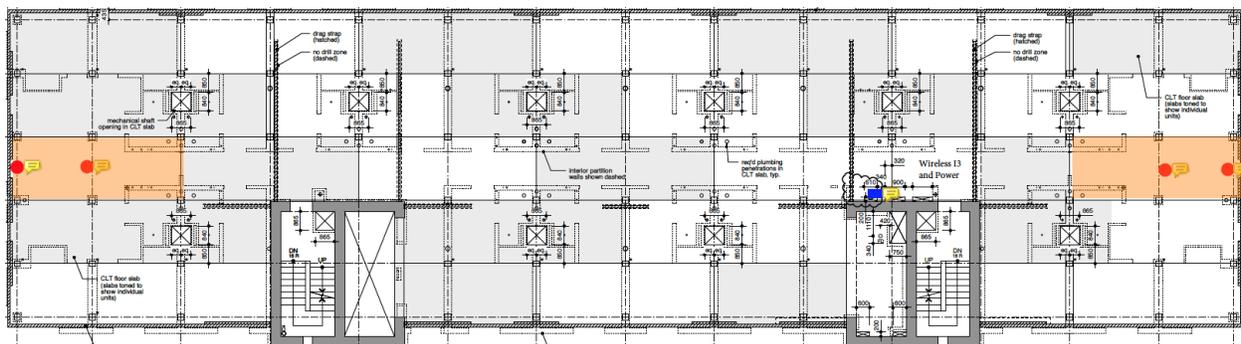
Locations were selected with the intent of obtaining data representative of the majority of environmental and construction related factors that are present during different phases of construction. Instrumentation accounted for points where CLT was uncovered, cement pours took place, floors changing from passive to active heating as the seasons shifted from summer to winter and material staging in the East wing. Recording a dataset that will be representative of the entire building during occupancy was also considered as monitoring will continue throughout the life of the building. Every second floor was monitored and areas alternated between North-South and East-West locations as shown in Figure 10 and Figure 11.

Figure 10: East West Moisture Monitoring Locations

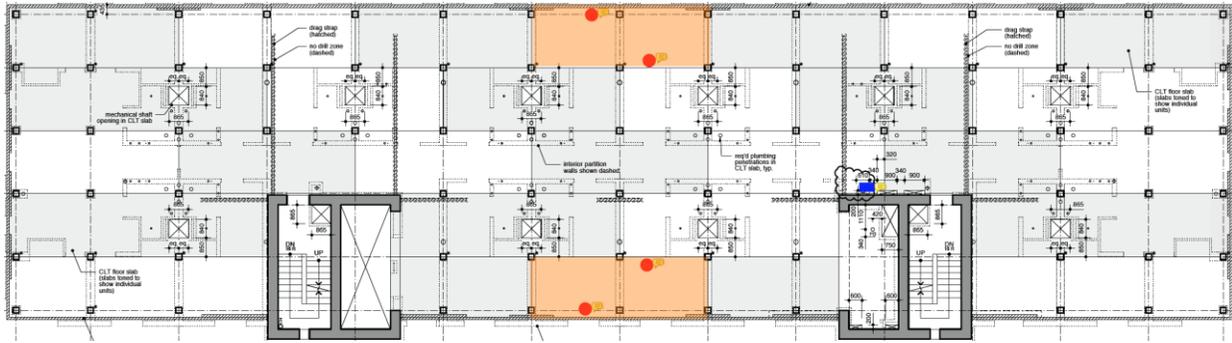
Figure 11: North South Moisture Monitoring Locations

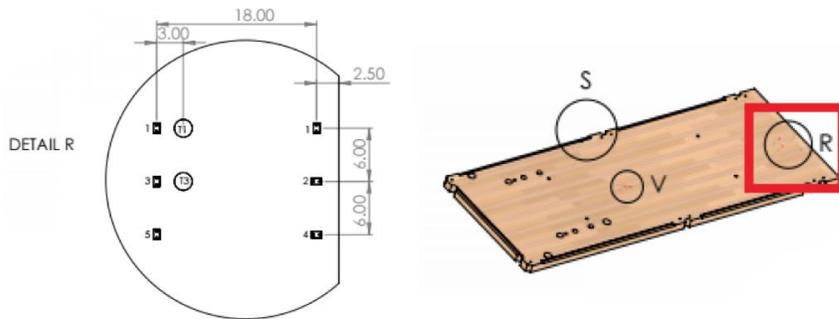
Key considerations taken in the building study were that MC1B probes are in the plywood spline of non-edge locations. In edge installations MC1B measures moisture at the surface level as close to the edge of the panel as reasonably possible. These layouts are documented in the figures below

Figure 12: Edge Panel Moisture Probe Locations

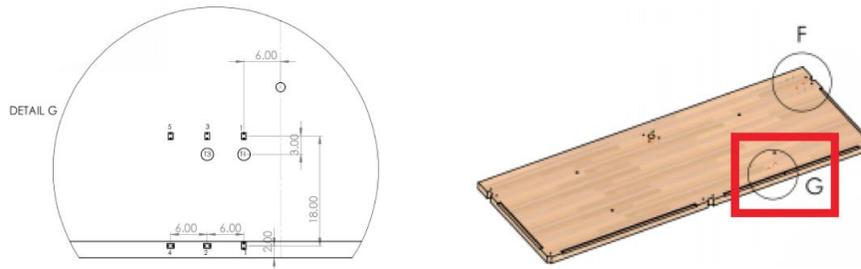
Figure 13: Plywood Spline Moisture Probe Location

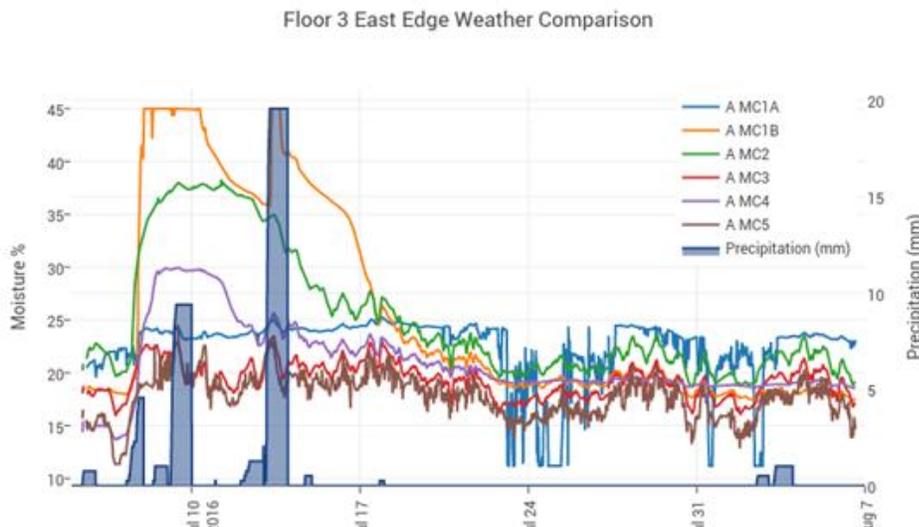
As discussed in the transportation study and the previous section, the CLT panels within the building dried to acceptable moisture levels during the year-long monitoring. While collecting data during construction the data-collection units had to be removed and reinstalled several times to work within the schedule of other contractors. This process can be refined in the future with increased conversation between contractors and involvement with the sequencing schedule. In Figure 14 CLT moisture performance after an exposed rainfall event is shown

Figure 14: CLT Moisture Performance After Exposed Precipitation Event

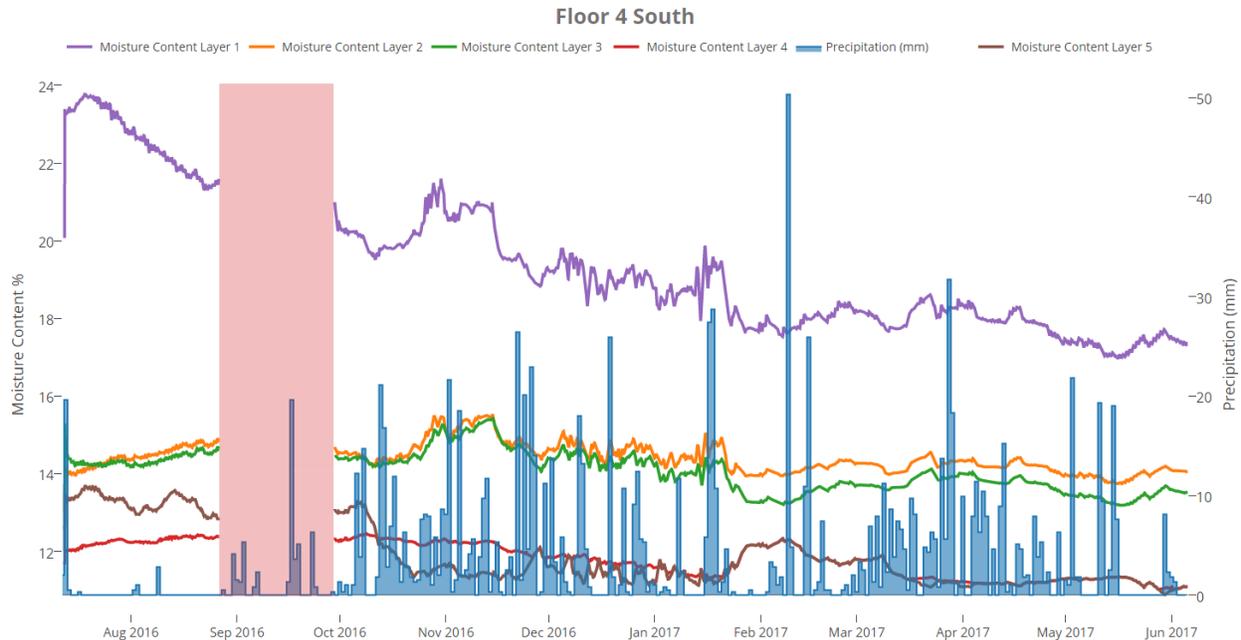
In Figure 15, moisture data collected over the course of a year is shown with precipitation as represented by the blue bars. Despite periodic precipitation, the CLT continued to dry during construction and after the building had been closed. The red area is a gap in data due to removal and reinstallation of the data collection unit to work around other contractors.

Figure 15: Year Long CLT Moisture Performance

Moisture performance of the CLT panels was analyzed with respect to these events as it was theorized that the CLT panels moisture levels would rise with the completion of the concrete floor topping. However, unless direct precipitation was in contact with the panels, the moisture levels did not change substantially. In event of direct moisture contact CLT panels would then quickly dry to acceptable levels. With the completion of the on-site water sealer used to improve the moisture protection of the CLT panels on-site and envelope panels, the overall moisture performance of the CLT panels became much more resilient to moisture. Year-long moisture performance of one location of the CLT is detailed in Figure 15.

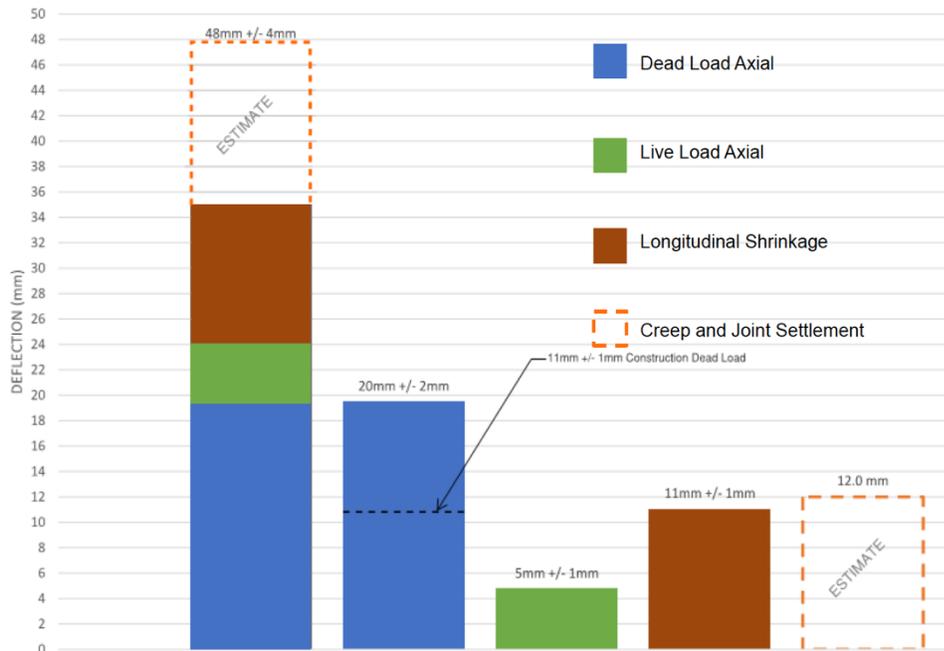
The axial column shortening was calculated to be 48mm. Of this, an estimate of creep and joint settlement is 12mm as shown in Figure 16. (Jackson, 2016)

Figure 16: Column Shrinkage Estimation Calculated (Jackson, 2016)

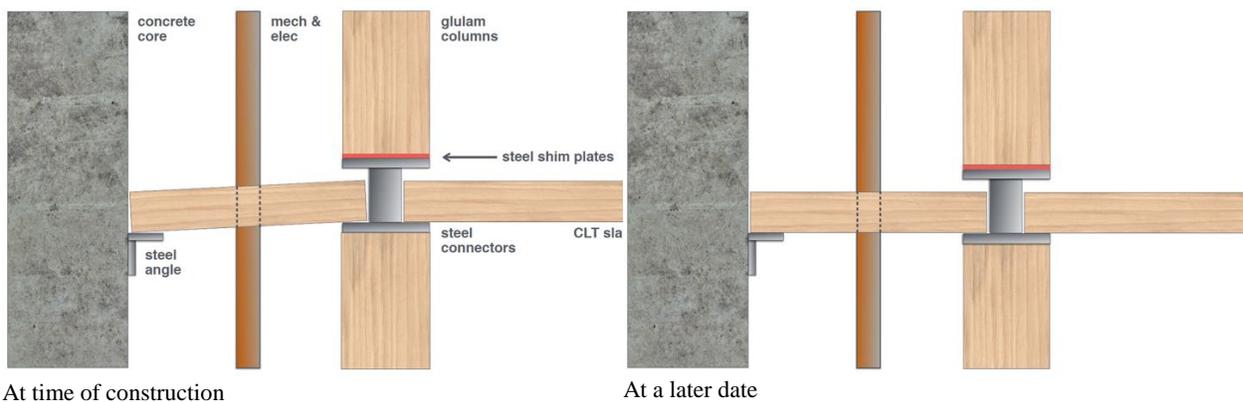
The difference between the axial concrete core shortening and the timber shortening is calculated to be 24mm. Provisions for axial shortening were mitigated by offsetting the connections for the CLT slabs so that they will naturally align after the building settles. (Jackson, 2016)

Figure 17: Setting Compensation in Structure Design (Acton, 2016)

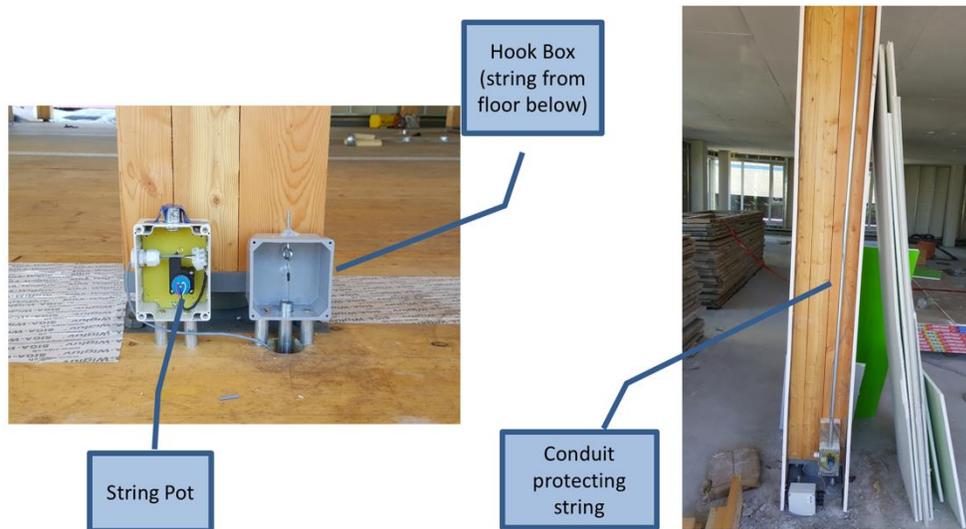
The measurement method consists of using a string pot sensor that contains a cable actuated position sensor connected to a spring loaded spool. The string is elongated using downrigger stainless steel non stretch cable and connects from the base of a selected column to the top of the floor above capturing the compression of the CLT and wood column.

Figure 18: String Pot Units installed In Structure

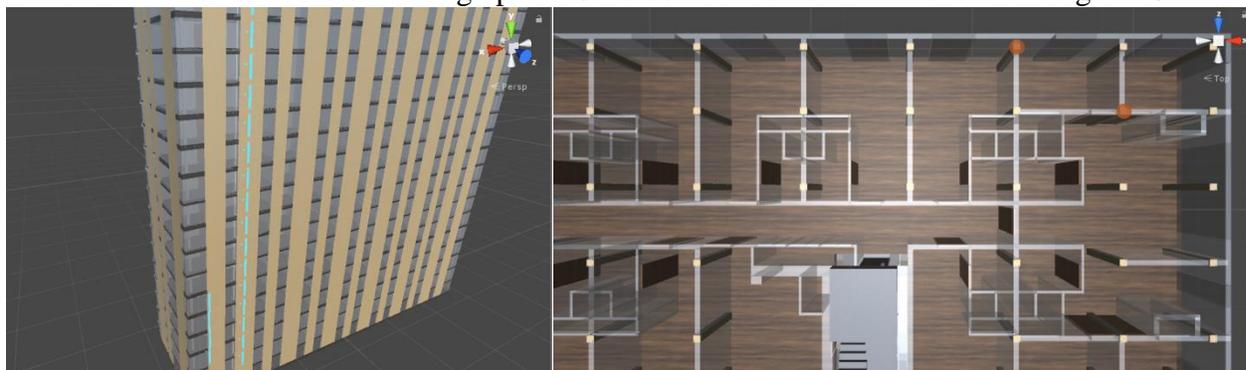
CLT columns from the base to the floor above were instrumented on the lower four inner floors and an all exterior columns extending up all 18 floors. The locations are shown in Figure 19.

Figure 19: String Pot Locations

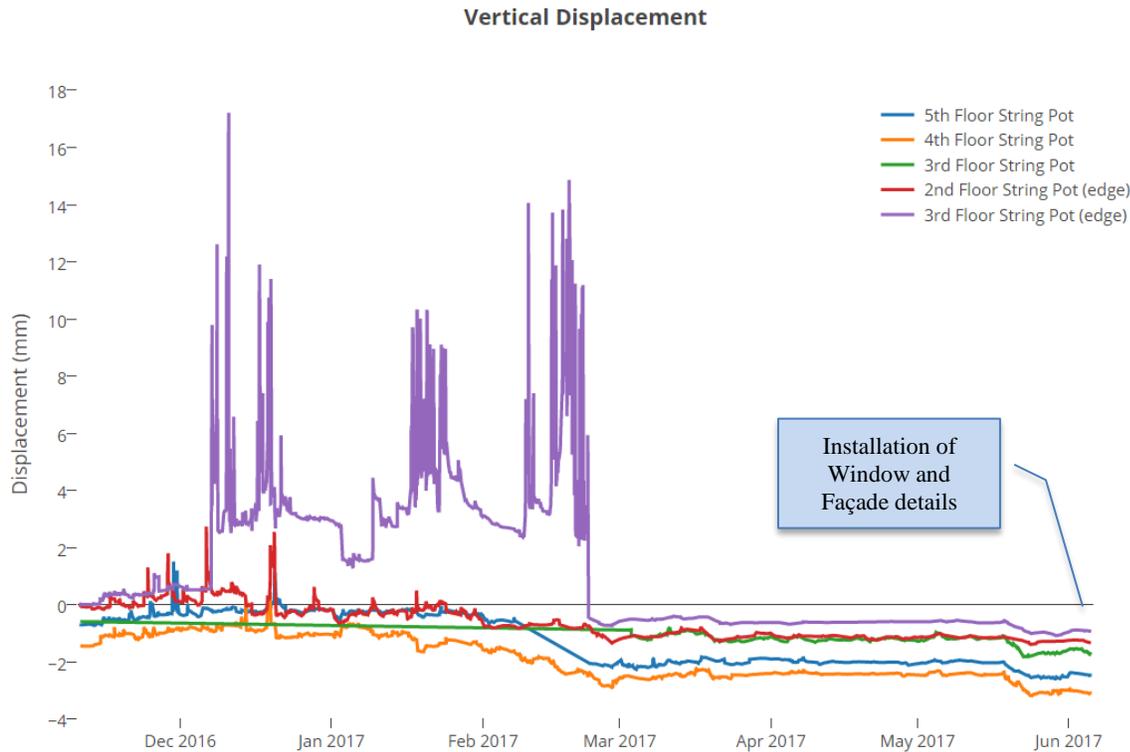
Upon commissioning, the sensors started at 0 mm displacement; positive displacement indicates there was an expansion most likely due to the shoring; negative displacement represents vertical compression. Figure 20 shows the vertical displacement of selected string pot sensors during construction. Vertical displacement sensors were disturbed by shoring used to support outriggers during construction.

Figure 20: Vertical Displacement Sensor Data

The shoring adversely affected the string pots while it was installed however after it was removed it did not appear to offset or skew the measurements. The edge columns and inner columns tracked each other as expected and the displacement on the outer column was less than the inner column as expected.

Approximately 1mm displacement was observed on all floors in May 2017, this occurred when the window and façade details were completed on the end units after the outriggers were removed.
