Field Measurement of Vertical Movement and Roof Moisture Performance of the Wood Innovation and Design Centre

April 2018

Contract Report

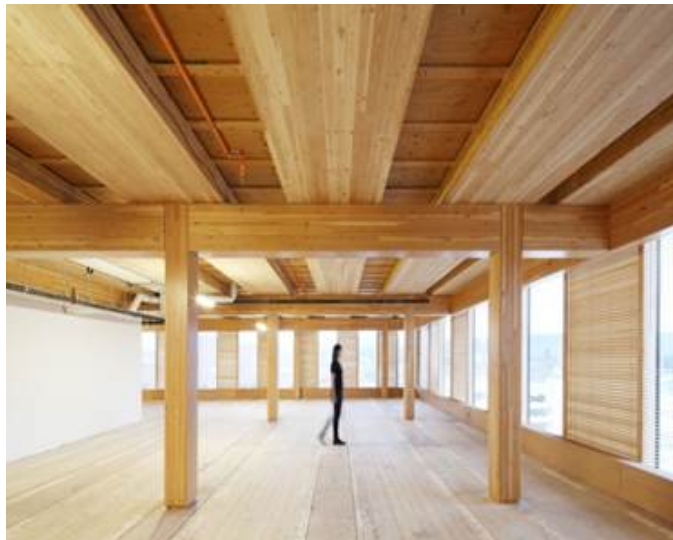
Figure 2 Mass timber roof structure integrated with an interior ventilation cavity between plywood roof sheathing and CLT panels below (Courtesy of Michael Green Architecture)

The design team suggested monitoring the moisture performance of the roof in the WIDC building to ascertain the drying performance of timber roofs. In the original design, 19-mm thick plywood roof sheathing would rest on sloped sleepers placed on staggered CLT panels. Although this solution would provide some air space to improve the drying performance compared with a common practice of directly installing plywood sheathing on CLT panels, there would still be some locations with poor drying capacity, particularly when the plywood is wetted before the roof membranes are installed. The design team revised and improved the roof design not long before the roof was built. Plywood strapping was instead installed between the CLT beams below and the plywood sheathing above in most areas of the roof to introduce an air cavity for interior ventilation (Figure 2; see the built roof in Figure 12). Knowing this improved design would greatly improve the drying capacity and reduce the moisture risk, interest remained in seeing how well the new system would perform. Six locations in the roof, covering different orientations and moisture risks were therefore selected for instrumentation to measure the moisture performance.

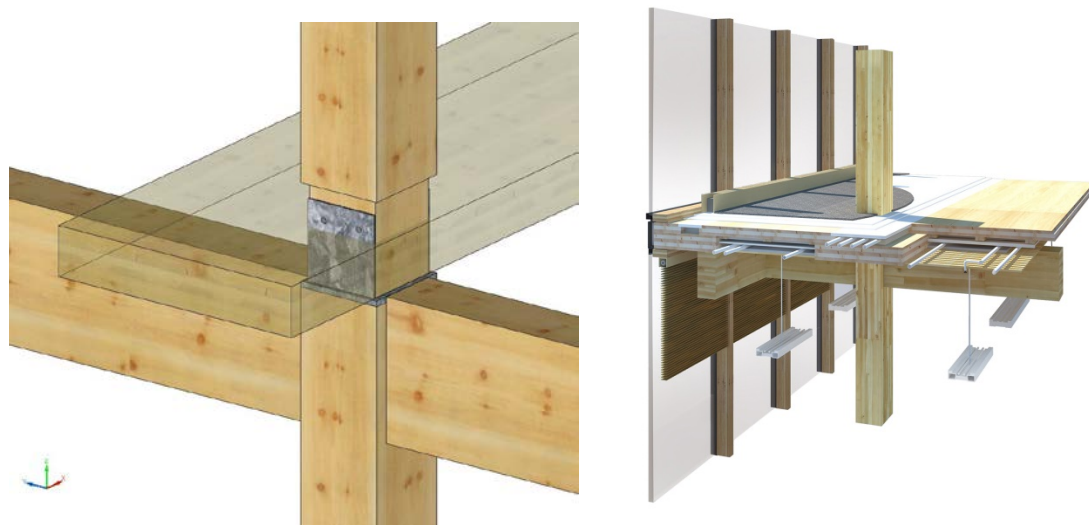
Figure 3 Left: Support of CLT floor slab with glulam column and beam (Courtesy of Equilibrium Consulting); Right: Vertically staggered CLT floor panels for providing chases to accommodate building services (courtesy of Michael Green Architecture)

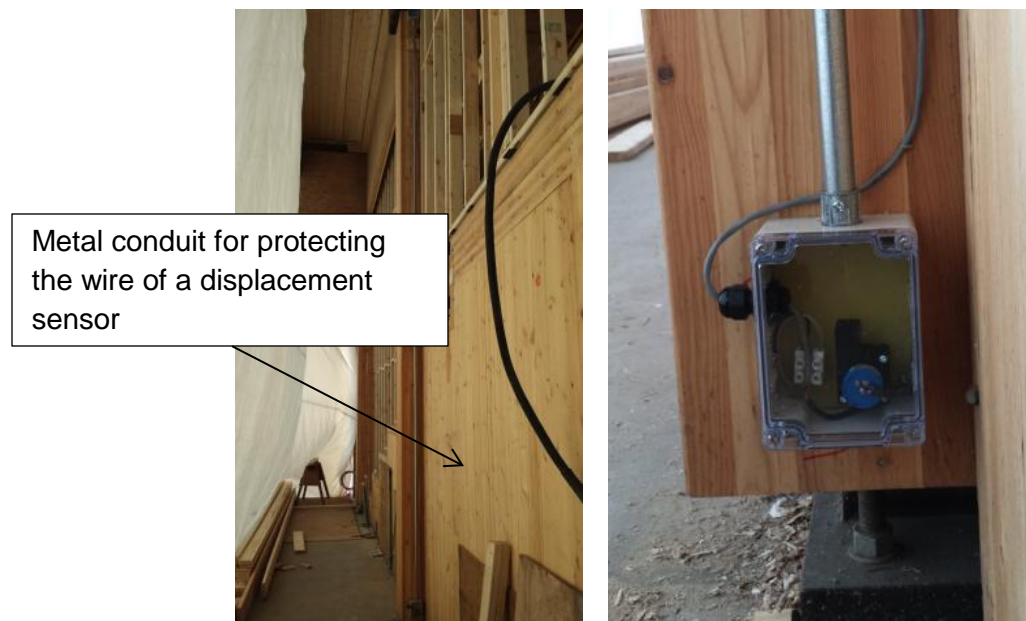
Figure 5 A displacement sensor (its metal conduit in left photo, and a closer image of the sensor box which is adjacent to the column base) at Location 1 for measuring vertical movement of the glulam column

⁴ These are Location 1 at GL C and GL 6.5 on Floor 1, Location 3 at GL 6.7 and GL B on Floors 2 and 3, and Location 4 at GL B and GL 4 from Floors 1 to 3 based on the drawings of the building.

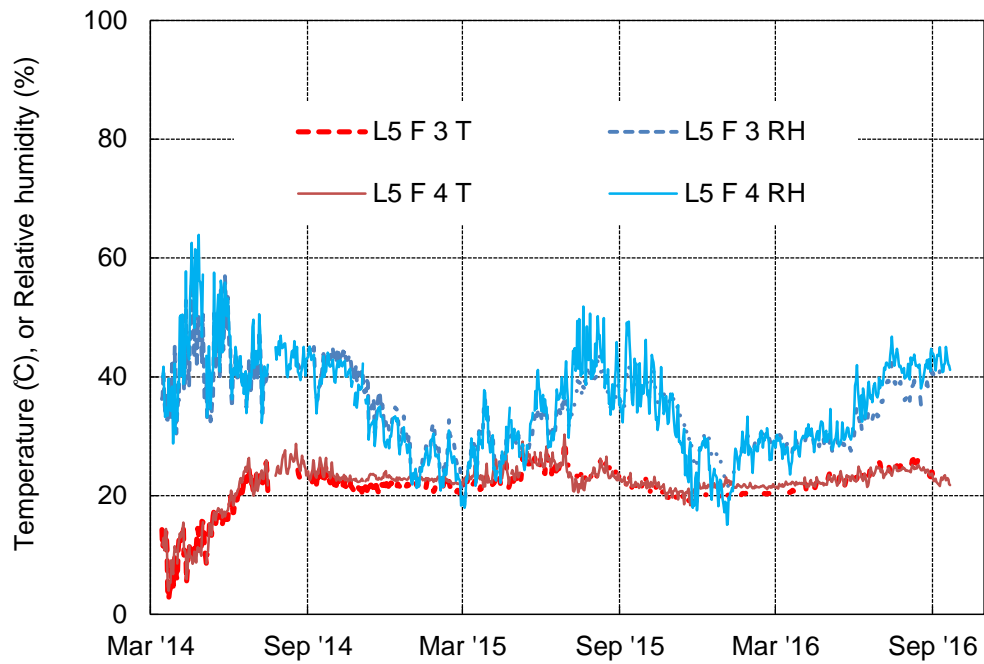
Figure 20 Relative humidity (RH) and temperature (T) on the 3rd and 4th floor (F3, F4) at Location 5 (L5)

The CLT shear wall has a total height of 24.5 m including two horizontal step joints based on the drawings. The vertical movement was only partially monitored from the 2nd floor to the 6th floor, as described in Section 5.3. Similar to the measurements of the two glulam columns at Locations 1 and 4, the shortening amounts measured from the CLT wall were also found to be small, ranging from 1.5 mm to 3 mm on each floor (Figure 19, with the service environmental conditions shown in Figure 20 and Figure 21). The measurements confirmed that CLT was

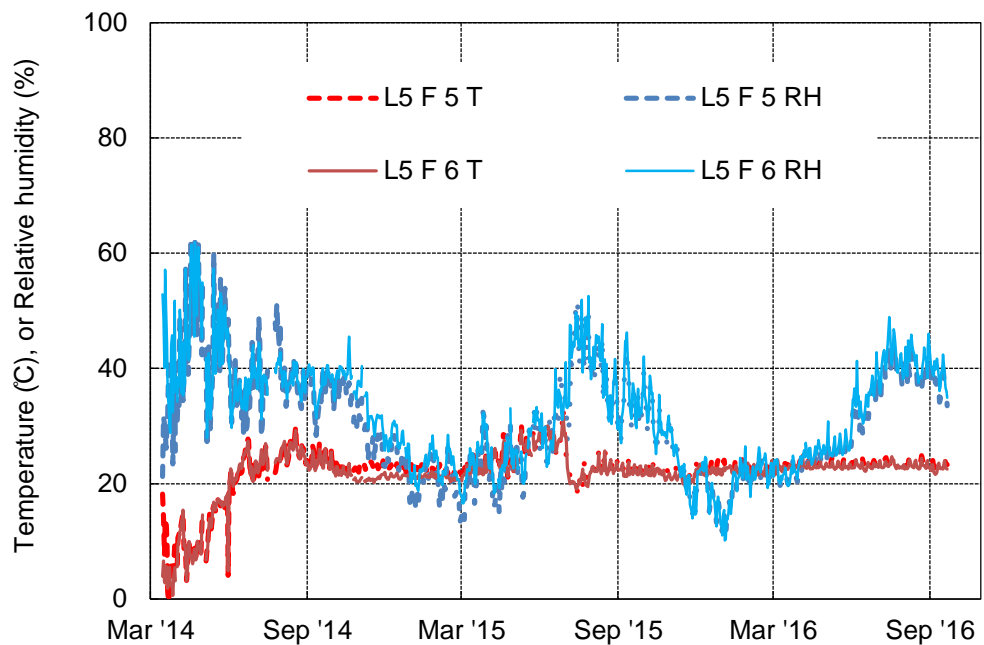
Figure 21 Relative humidity (RH) and temperature (T) on the 5th and 6th floor at Location 5 (L5)

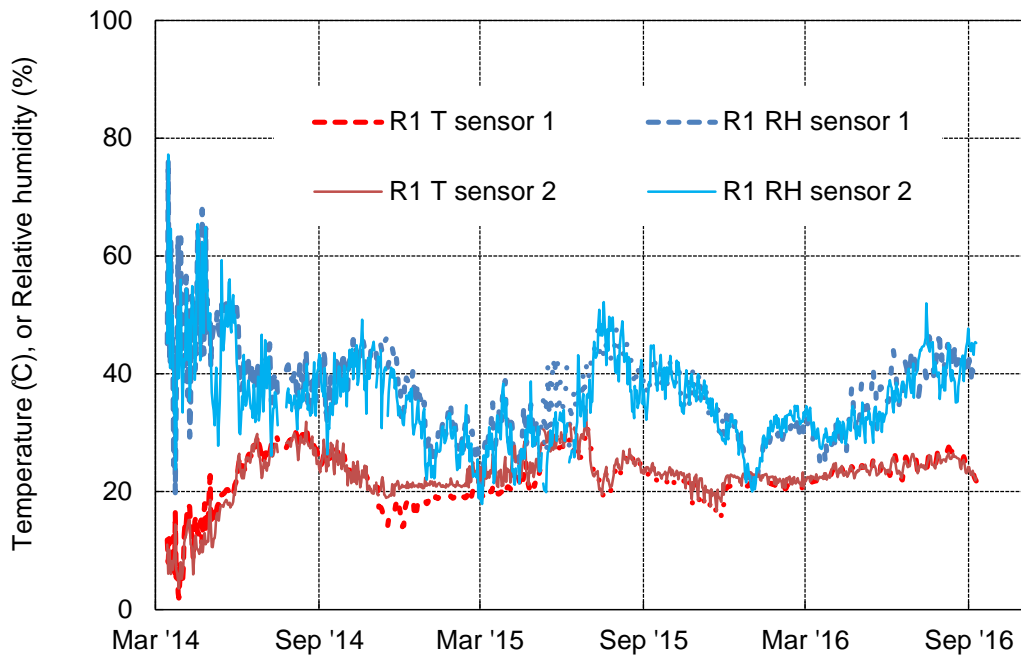
Figure 22 Relative humidity (RH) and temperature (T) at Roof 1 location (R1) measured with two RH/T sensors

The wood roof structure of this building in general remained dry during the entire monitoring period of time. Figure 22 shows the RH and temperature measured from Location R1 to represent the overall service environmental conditions in the roof area. Consistent with the ambient conditions measured from lower floors, the RH was overall below 50% in the summer and reduced to 20% in the winter at most locations of the roof. As a result of the dry indoor environment, both the plywood roof sheathing (Figure 23) and the CLT panels below (Figure 24) showed MC readings close to 11% after the initial construction stage at five of the six monitoring locations (i.e., except R4). It should be noted that the resistance-based measurement systems has a lower MC limit of 11% when the calibration is based on lodgepole pine⁹. Therefore a reading of around 11% may indicate lower real MC.

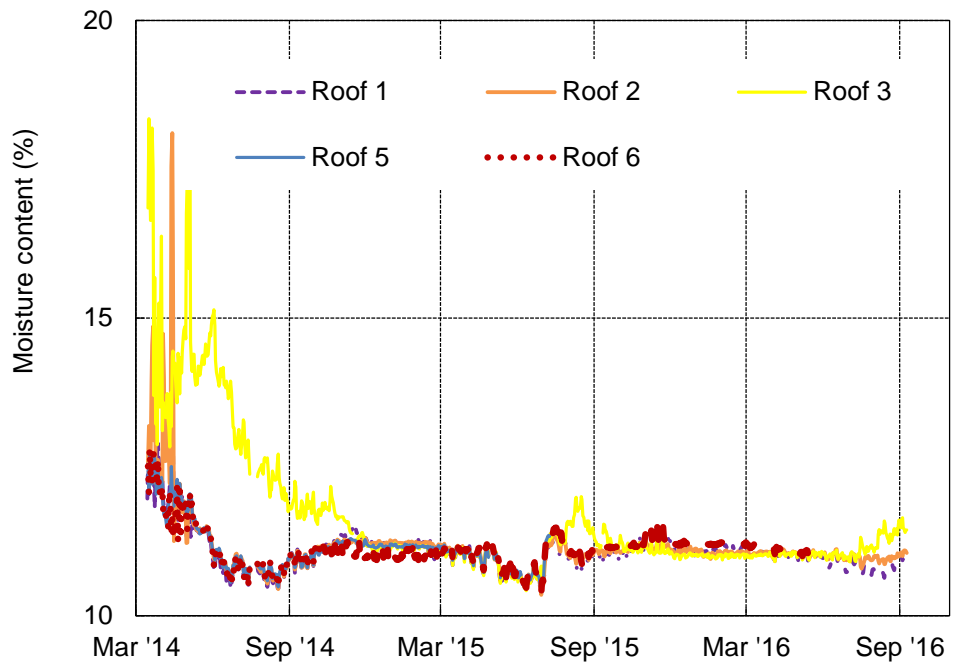
Figure 24 Moisture content measured from CLT beams at five roof locations

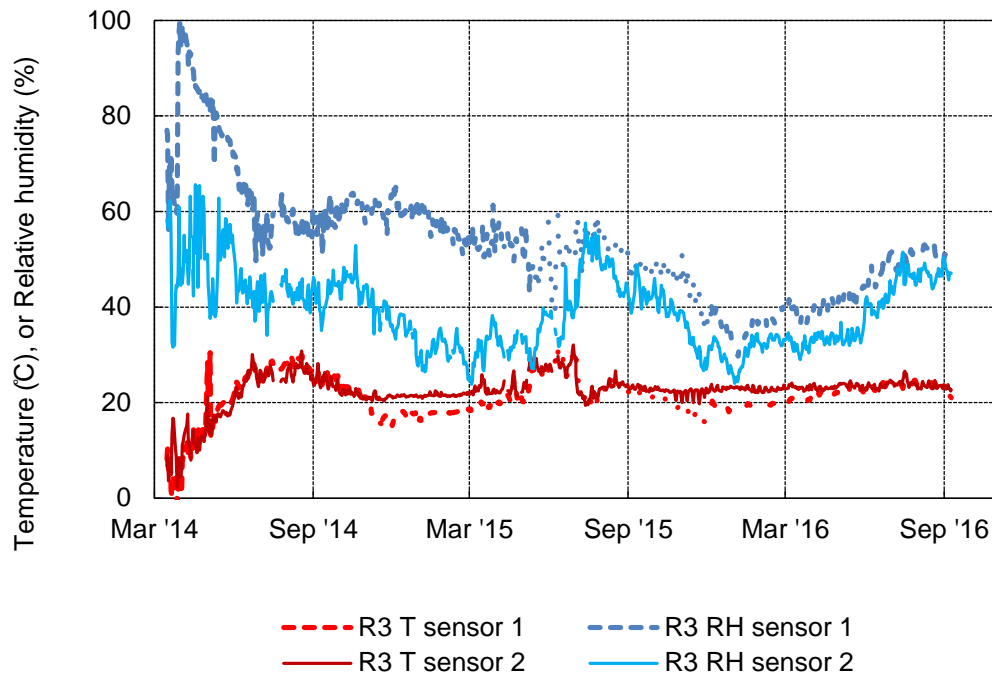
Figure 26 Relative humidity (RH) and temperature (T) measured from Roof 3 location (R3) with two RH/T sensors
