Freeze-Thaw Durability of Anchor Materials in Heritage Masonry Stones

Abstract: Repair of heritage stone masonry structures sometimes involve anchoring the walls, to prevent from separation and to increase integrity of the walls. Performance of these anchors significantly depends on their ability to resist debonding forces induced from environmental freeze-thaw. Before choosing any anchoring materials for a heritage structure repair, capability of these materials in forming a sound bond with the existing masonry materials of that structure needs to be examined. A study was conducted at the University of Manitoba in collaboration with the Public Works and Government Services Canada (PWGSC), to test the behaviour of several anchors in stones. Conventional anchoring materials consist of steel, grout, and epoxy. On the other hand, suitability of Glass Fibre Reinforced Polymers (GFRP) to overcome the corrosion related problems of steel is well established. Keeping this aspect in mind, innovative anchors made from GFRP bars were also incorporated in this research program. Experimental program involved small scale replication of stone-anchor assemblies followed by monitoring of these ass

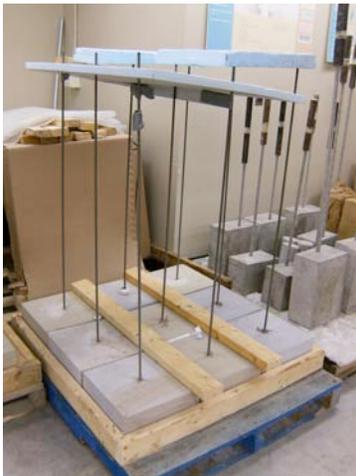
Figure 1: Completed stone-anchor specimens.

Seventy specimens were used in the study. Of these seventy, sixty four were stone-anchor assemblies and six were plain stones (two from each type of stone). Several stone-anchor specimens are presented in Figure 1. For each type of stone-anchor assembly, there was one control specimen that was not exposed to environmental loadings. Except for the control specimens, the specimens from each stone-anchor assembly were exposed to harsh environmental loadings before conducting permeability tests. These specimens are called conditioned samples in this report. Freeze-thaw cycles that were selected in this research are based on the actual climate data of the Western Canada region. The data were recorded and supplied by Public Works and Government Services Canada (PWGSC).

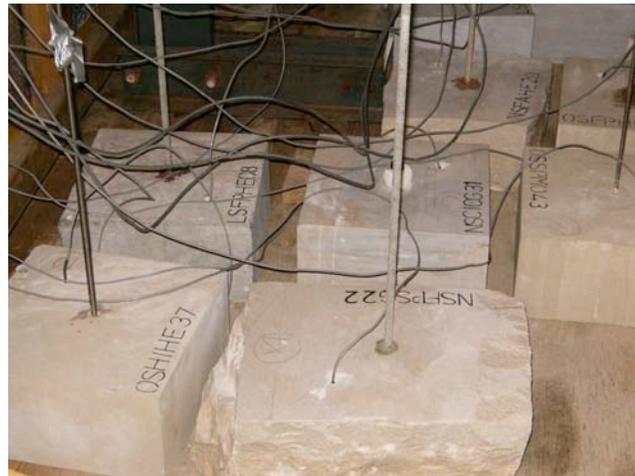
Figure 2: Stone-anchor assemblies with embedded sensors in the environmental chamber.

permanent epoxy so that moisture could not infiltrate to the sensor through this opening. Selected stone-anchor specimens with embedded moisture sensor are presented in Figure 2.
