MOISTURE PERFORMANCE AND VERTICAL MOVEMENT MONITORING OF PRE-FABRICATED CROSS LAMINATE TIMBER – FEATURED CASE STUDY: UBC TALLWOOD HOUSE

G. Mustapha, K. Khondoker, J. Higgins

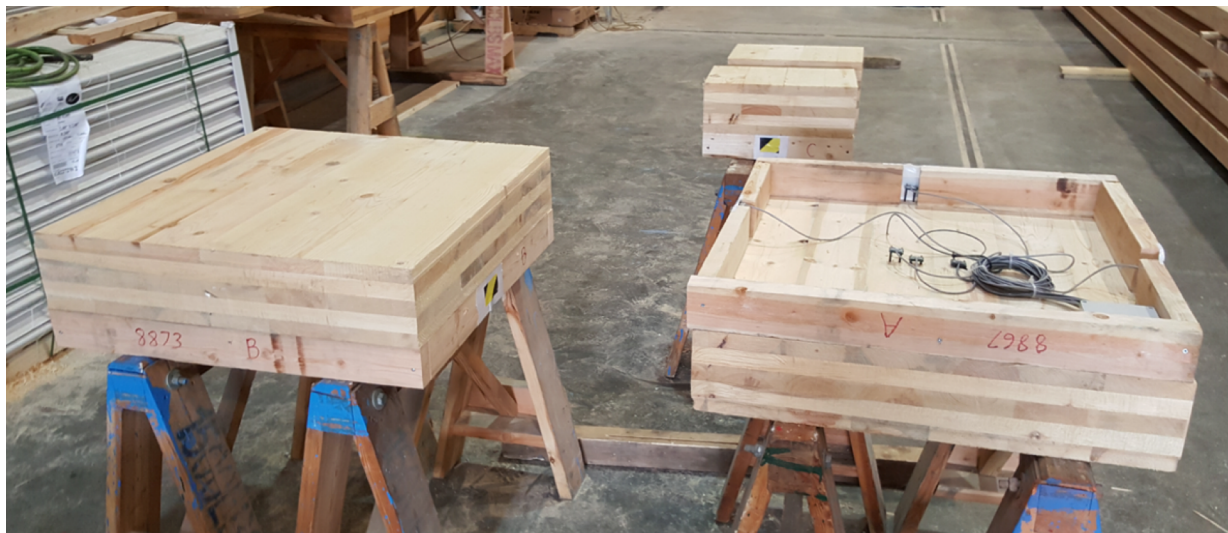
Figure 3: Instrumented Off-cuts – May 7th, 2016-06-01

During the first trip, 2 large offcuts were outfitted with sensors, as well as 2 smaller CLT blocks. During the second trip, 6 large offcuts were instrumented and stored. All offcuts were coated with the same products and in the same manner as the full-size floor panels. The offcuts were then wrapped in plastic, stacked and stored alongside the full-size panels. Wood slats were placed in between each panel to increase airflow to the panels and prevent any potential moisture buildup, similar to how the full-size floor panels were stored.

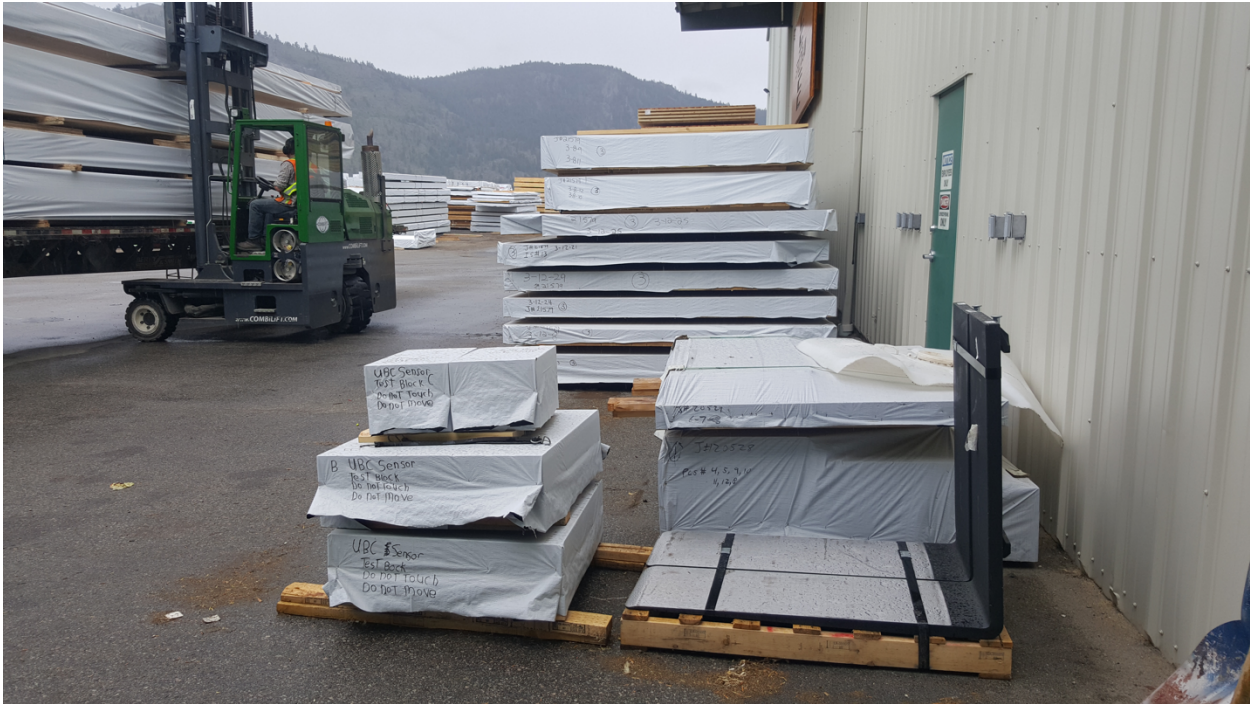
Figure 4: Off-cuts Stored outside alongside full size CLT panels

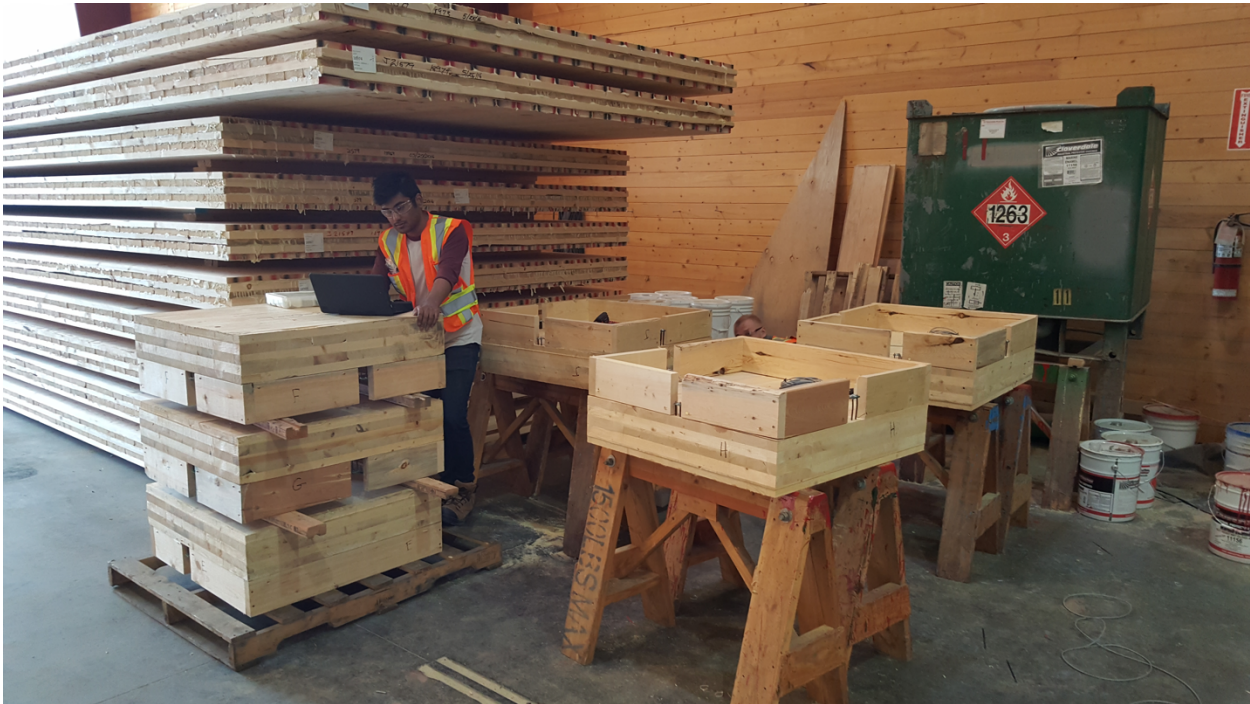
Figure 5: Six additional off-cuts were instrumented on May 27th, 2016-06-01

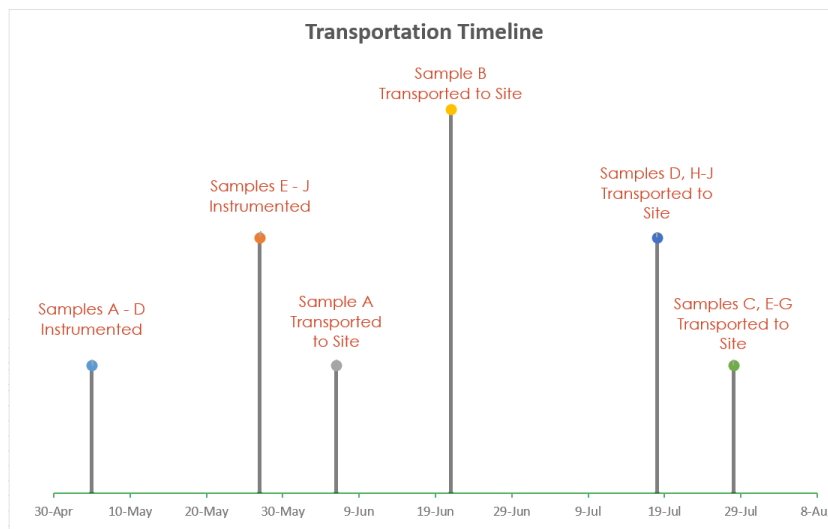
The timeline and path of travel for the transportation CLT samples are as shown in Figure 6 and Figure 7 below. Samples were shipped with different floor panel shipments to create a diverse set of data with the possibility of varying environmental and logistical conditions.

Figure 6: Transportation Timeline of Samples

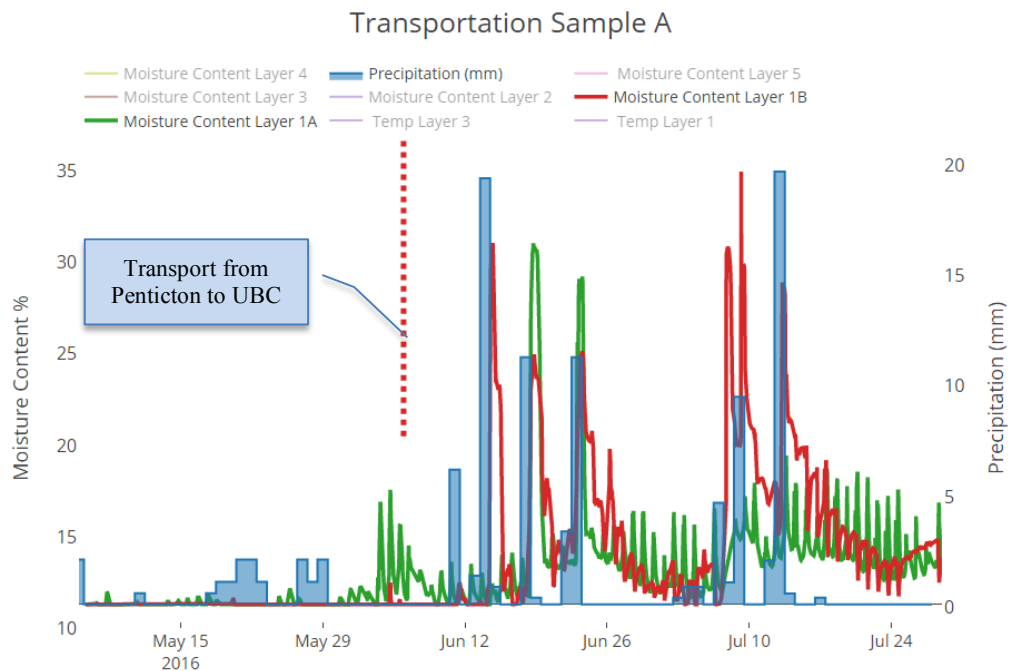
Data from Transportation Sample A which arrived and was uncovered to reflect the conditions of the CLT of the structure showed the effectiveness of the processes the CLT manufacturer implemented while storing and transporting the CLT panels for this project. As seen in Figure 9 prior to shipping, moisture levels in the CLT samples stayed very consistent and were did not appear to be exposed to moisture.

Figure 9: Analysis of Sample A during Transport

Once uncovered and exposed to a series of rainfall events, the effects can clearly be seen in a spike of moisture levels in the topmost layer of the sample. Data from the top layer of CLT is shown in Figure 9 with the dotted red line indicating the day of transport from Penticton to the building site at UBC. The rapid decrease of sample moisture demonstrated the drying ability of the fully-exposed CLT. These observations of the CLT are consistent with observations which were made in later analysis of the in-building moisture levels during construction.

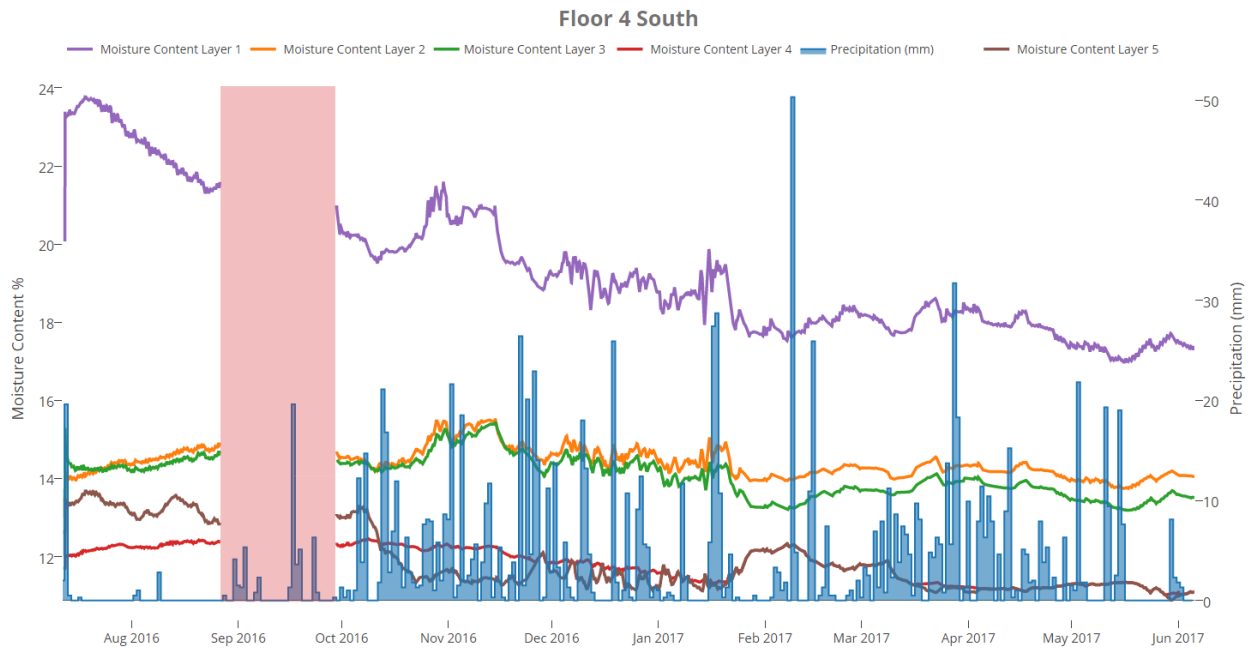
In Figure 15, moisture data collected over the course of a year is shown with precipitation as represented by the the blue bars. Despite periodic precipitation, the CLT continued to dry during construction and after the building had been closed. The red area is a gap in data due to removal and reinstallation of the data collection unit to work around other contractors.

Figure 15: Year Long CLT Moisture Performance

Moisture performance of the CLT panels was analyzed with respect to these events as it was theorized that the CLT panels moisture levels would rise with the completion of the concrete floor topping. However, unless direct precipitation was in contact with the panels, the moisture levels did not change substantially. In event of direct moisture contact CLT panels would then quickly dry to acceptable levels. With the completion of the on-site water sealer used to improve the moisture protection of the CLT panels on-site and envelope panels, the overall moisture performance of the CLT panels became much more resilient to moisture. Year-long moisture performance of one location of the CLT is detailed in Figure 15.

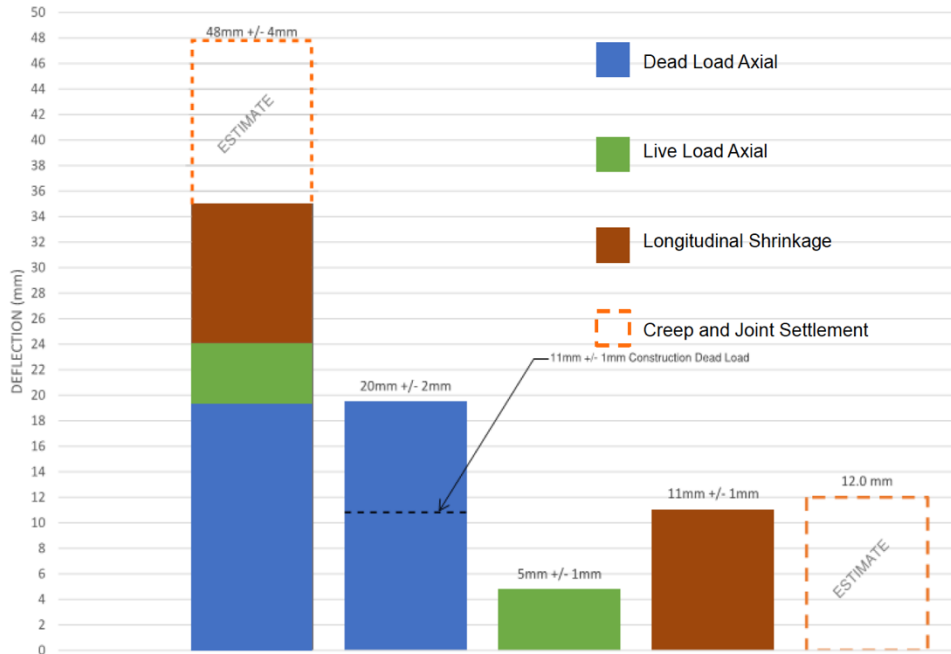
The axial column shortening was calculated to be 48mm. Of this, an estimate of creep and joint settlement is 12mm as shown in Figure 16. (Jackson, 2016)

Figure 16: Column Shrinkage Estimation Calculated (Jackson, 2016)

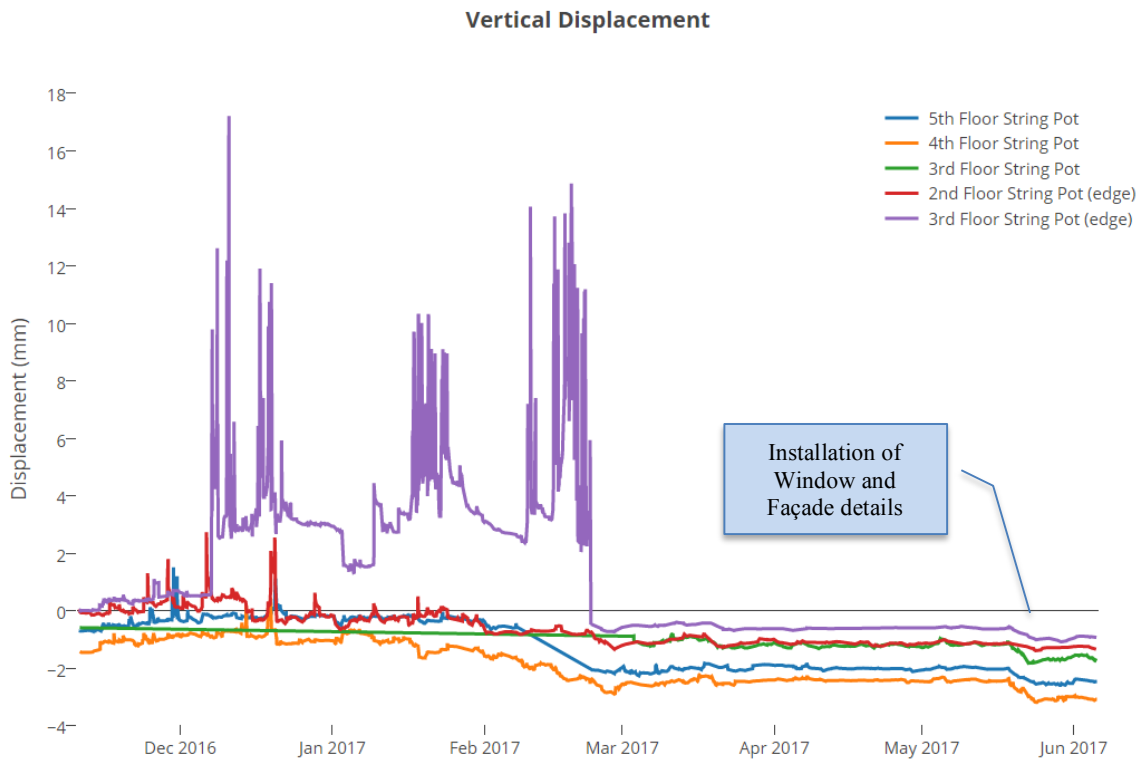
Upon commissioning, the sensors started at 0 mm displacement; positive displacement indicates there was an expansion most likely due to the shoring; negative displacement represents vertical compression. Figure 20 shows the vertical displacement of selected string pot sensors during construction. Vertical displacement sensors were disturbed by shoring used to support outriggers during construction.

Figure 20: Vertical Displacement Sensor Data

The shoring adversely affected the string pots while it was installed however after it was removed it did not appear to offset or skew the measurements. The edge columns and inner columns tracked each other as expected and the displacement on the outer column was less than the inner column as expected. Approximately 1mm displacement was observed on all floors in May 2017, this occurred when the window and façade details were completed on the end units after the outriggers were removed.
