Wind Uplift Capacity of Foam-Retrofitted Roof Sheathing Subjected to Water Leaks

ABSTRACT

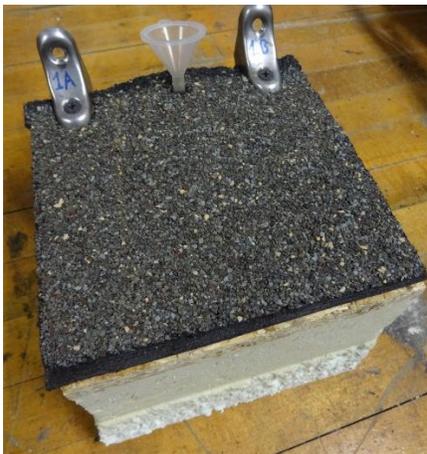
Figure 11: 6”x6” samples representing typical roof conditions

The small-scale testing in Phase II consisted of monitoring visual and physical changes in 6” x 6” samples, illustrated in Figure 11, exposed to a single water leak source. Water is applied at constant flow rate of ~1-3 mL/min to samples consisting both control roof decks and roofing and ccSPF-retrofitted ones. The study was designed to simulate several roof geometries that encourage water absorption, including presence of horizontal and vertical joints in the sheathing, wood framing, plywood versus OSB sheathing, roof slope and self-adhered waterproofing membrane underlayment.

The samples consisted of 6" x 6" pieces of OSB or plywood roof decks as described above, with asphalt roofing shingles and felt underlayment placed on top. The roofing system was held in place but not permanently fastened to the deck, to simulate the weight, and proximity of materials in actual roof construction. A small funnel with its stem passing through the shingle and underlayment was used to ensure maximum volume of water is applied directly to the top surface of the wood roof sheathing. Temperature and relative humidity were monitored over the course of the testing. Results of the small-scale testing were not yet available at the time of writing.

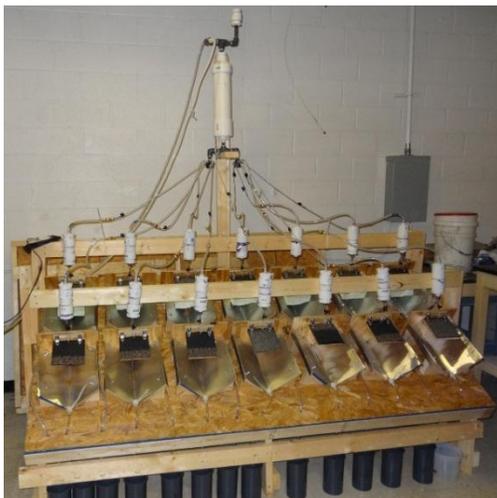
Figure 12: Phase II Small-Scale Test Setup

A novel test setup was created, in order to accommodate tests on relatively large number of samples using very low water flow rates (Figure 12). A continuously-filled volume of water provided a constant head pressure to fourteen drip regulators. Each drip regulator was constructed with PVC pipe with a cross-section as shown in Figure 13, so as to provide a continuous drip at a rate of approximately 2 mL/min, arbitrarily chosen to simulate a possible leak rate into the roof system for a small leak during a typical rain event. Samples were mounted to basins with sloped sides constructed of sheet metal, serving to capture all water runoff. The captured water was directed through the tubing to collectors. The entire test setup was mounted on a frame oriented to a 6:12 or 4:12 slope.
