This Project and Research was completed with SMT Equipment and engineering services.
Presented at Ashrae Buildings XII Conference, December 2013

Highly Insulated, Ventilated, Wood-Framed Attics in Cool Marine Climates

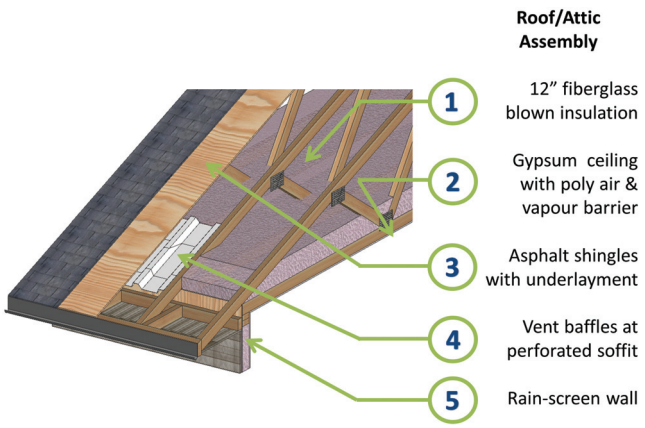
Figure 8 *Attic construction and ventilation*

The attic construction and ventilation (shown in Figure 8) is typical of sloped roofs for wood-framed buildings in coastal BC. As required by code, the venting area is provided at the top of the attic near the ridge line and at the bottom of the attic space at the soffits at opposite ends. The vents at the ridge are square low profile vents and baffles are installed at the soffits. Unit 4 is the end of the building and is part of the hip roof end.

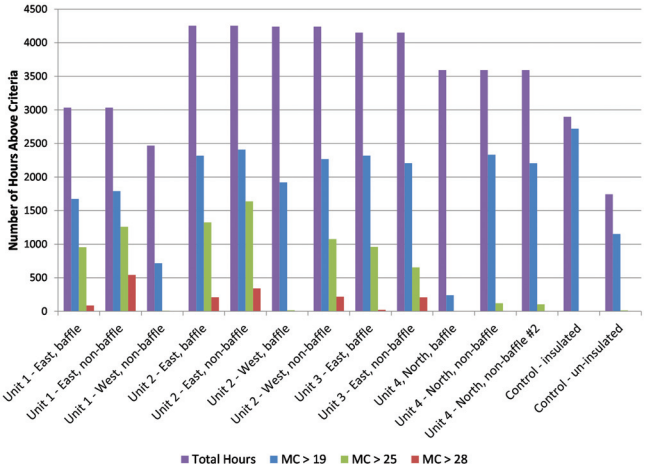
Figure 12 *Duration of elevated sheathing moisture levels.*

The staining and occurrence of high sheathing moisture levels are correlated, but the highest moisture for the longest duration did not necessarily coincide with the most visible staining. For example, the heaviest staining was observed at Unit 1 at the east baffle, Unit 2 at the east baffle, and Unit 3 at the west baffle, but some of the highest moisture levels were recorded at Units 1, 2, and 3 at the east non-baffle location.[7] Figure 12 summarizes the duration (hours) of elevated sheathing moisture levels and Table 8 summarizes observations of staining at the sensor locations at the start of the monitoring period.

Two significant moisture spikes occurred that affected the long-term sheathing moisture levels of the east soffit for Units 1, 2, and 3 during the winter of 2011/2012. Spikes in the moisture levels occurred on December 10 to 12th, 2011 and January 12, 2012. These events are discussed further in the next sub-section, diurnal wetting.

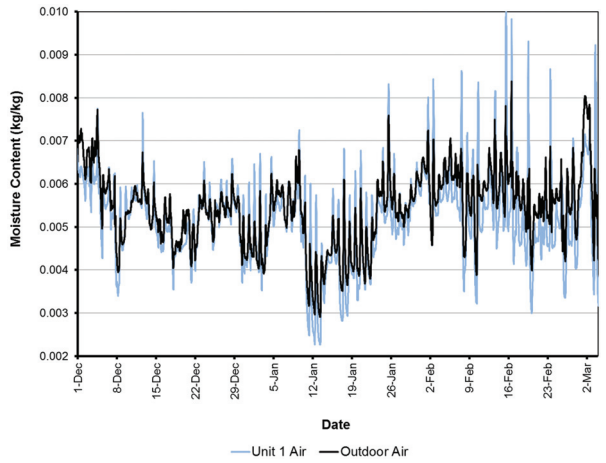
Figure 13 *Unit 1 attic and outdoor air moisture levels per time.*

Another important observation showing that outdoor air is the principal source of wetting of the attic sheathing is the attic air has essentially the same overall moisture level as the outdoor air. Figures 13 and 14 show the attic air moisture content for Unit 1 compared to the outdoor air moisture content. The time series graph in Figure 13 shows that the attic air follows the same trend as the outdoor air. The scatter plot in Figure 14 shows that on average the attic and outdoor air are at the same moisture levels, with the attic air being slightly drier than the outdoor air at high moisture content levels.

Note that the times where the attic air moisture content levels are higher than the outdoor moisture levels coincide with decreasing moisture content levels in the sheathing and elevated sheathing temperatures (i.e., moisture is driven out of/into the wood to/from the attic air depending on the relative difference in vapour pressures).

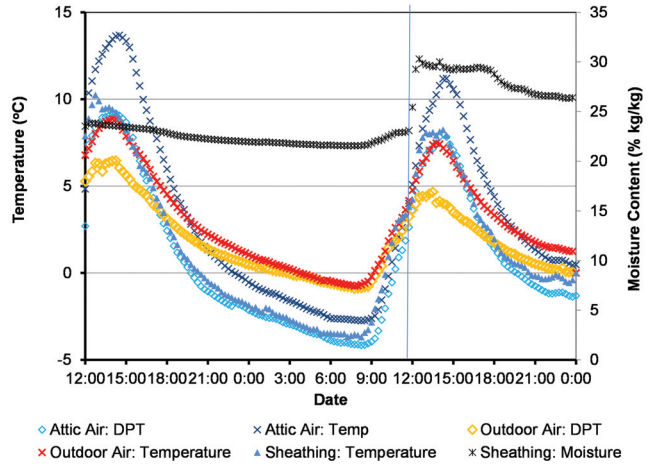
Figure 15 *Unit 1 sheathing moisture spike after night-sky cooling on December 12, 2012.*

Sharp spikes in the sheathing moisture content occurred in all the units at the same time and appeared to happen when moisture was deposited by condensation or frost as a result of surfaces cooled by night-sky radiation that was subsequently exposed to warmer humid outdoor air as temperatures rose in the daytime. Figure 15 illustrates these conditions for Unit 1 on December 12, 2011. Review of the weather records for the night before this wetting event showed periods of clear skies during the night, and this was also the case for the night before the significant wetting period on January 12, 2012 and in January 2013.
